Lesson learnt from JAC Storage Tank Fire

Incident summary:

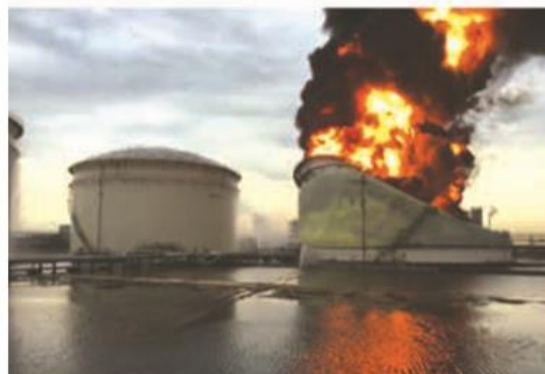
On 20th April 2016, a major fire broke out at former Jurong Aromatics Complex (JAC) facility in Jurong Island, Singapore. The fire started at a condensate storage tank which developed very rapidly, and ensued into a full surface tank fire within minutes of initial roof collapse. The tank involved was a 46.6 metre diameter, internal floating roof type storage tank, and the fire took about 5 hours to extinguish.

The primary cause of fire was suspected to be due to lightning strike. The extended roof collapsed and subsequently, fire spread to the entire tank. This fire incident is a reminder to tank storage facility owners on the importance of rim seal design, roof earthing assembly and associated fire protection provision.

Countries like Singapore are subjected to high lightning strike rate, where each square kilometre of land can be struck up to 16 times annually. Therefore, extra considerations should be provided for floating roof earthing design and rim seal fire protection on low flash point liquid storage tank facilities.
