Bridging Safety Gaps in Combustible Dust Management – Lesson and prevention strategies from past incidents

November 20, 2024

Dilip Arulappan
Explosion Safety Consultant

Case study – Didion Milling

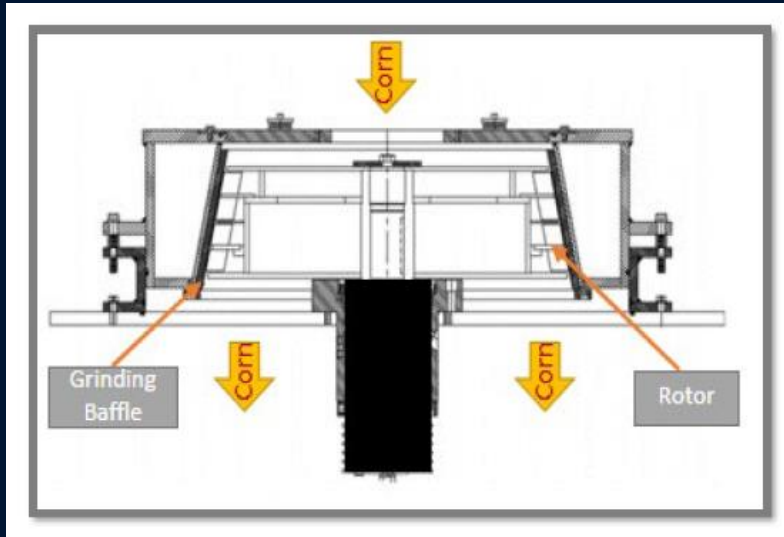
Cross section of a gap mill rotor and grinding baffle.
(Credit: Bauermeister; annotations by CSB)

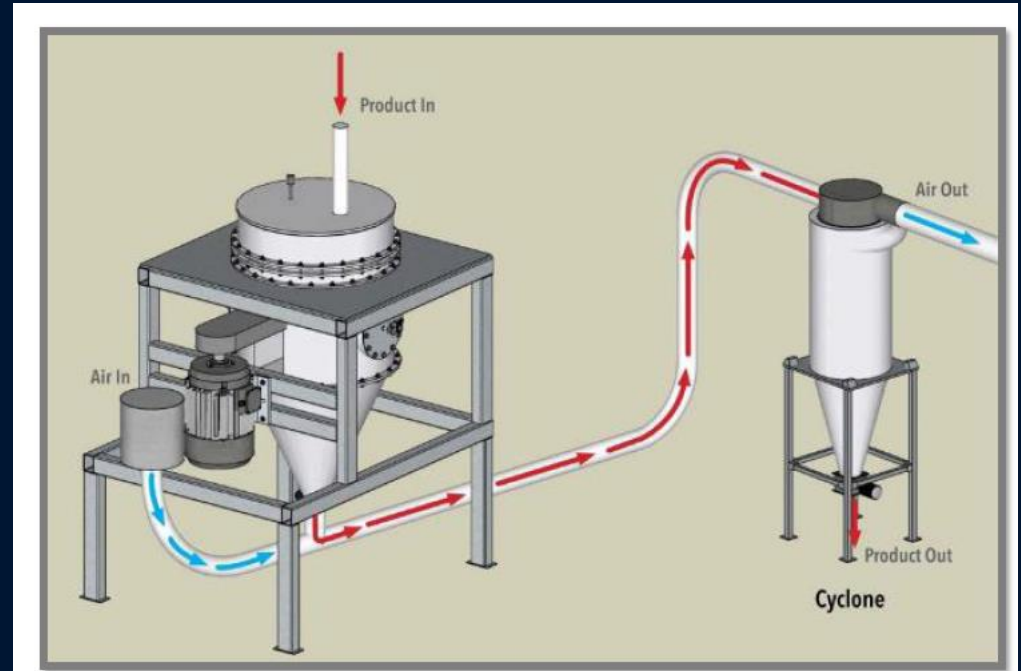
Diagram of South gap mill (South BM) and South BM discharge cyclone.
(Credit: CSB)

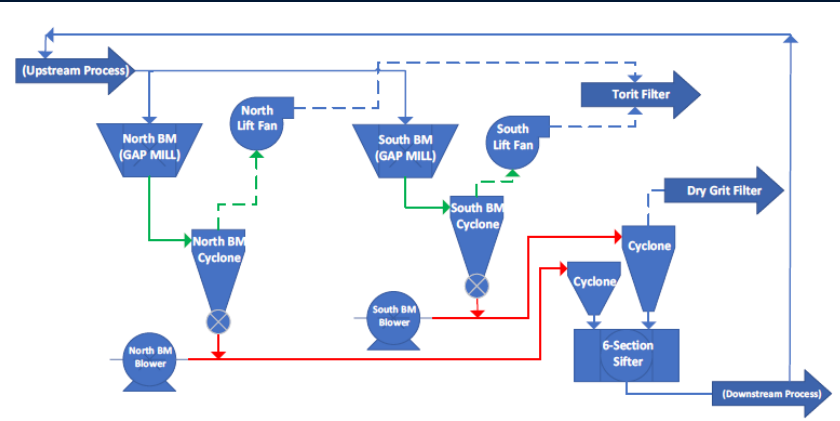
Typical localized bran system process flow for North and South BMs. Vacuum pneumatic conveying lines are shown in green, and pressure pneumatic conveying lines in red. (Credit: CSB)

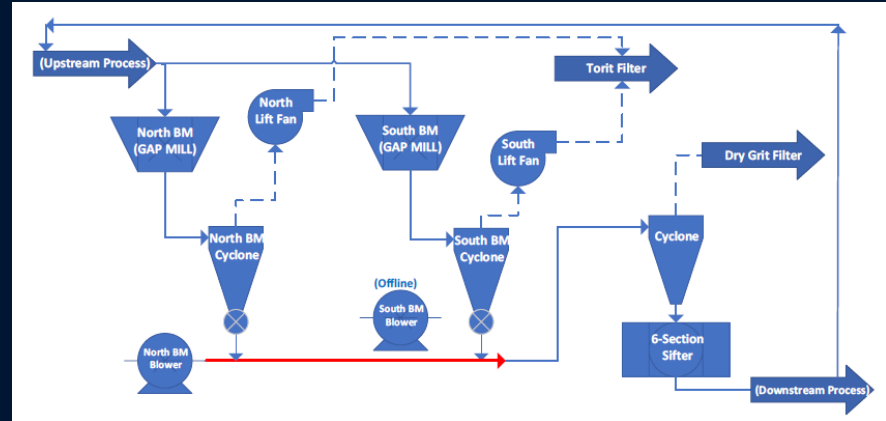
Temporary line (Credit: CSB)

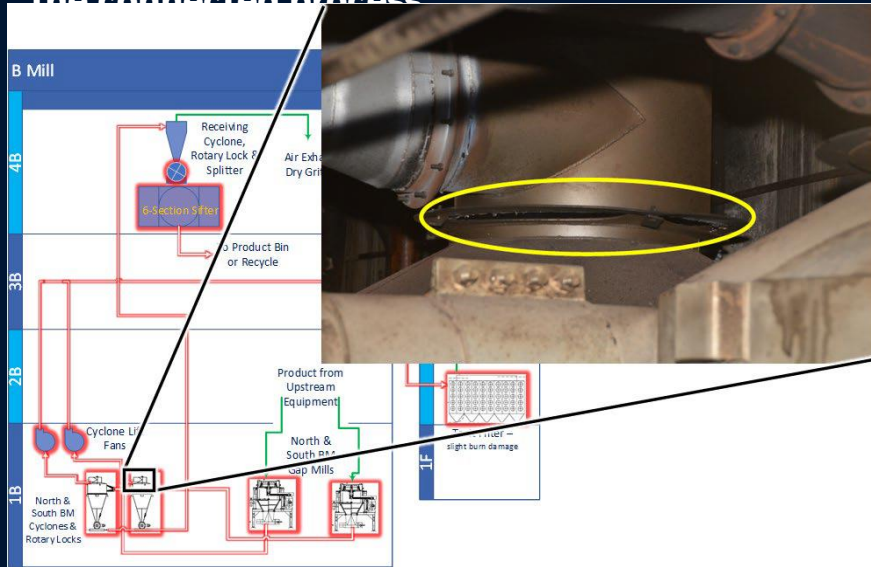
‘The CSB concludes that an explosion downstream of the South Gap Mill in 1B occurred, which propagated through the North and South BM Cyclones and continued to propagate throughout the connected process.’

Top (discharge) section of South BM receiving cyclone, separated from body at flange (circled) from an overpressure inside the equipment. (Credit: Didion inset; CSB background)

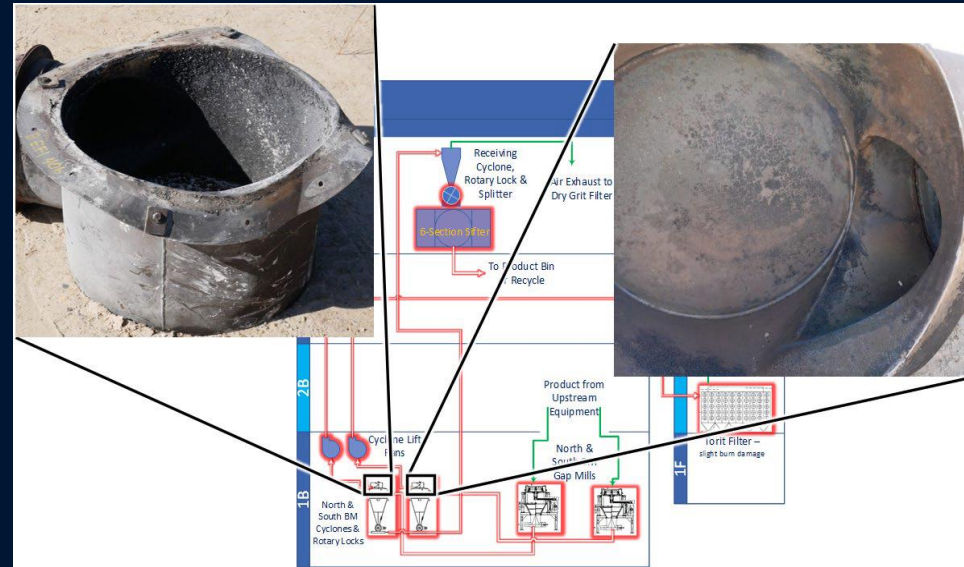
Burn damage inside the top of North (left) and South (right) BM Cyclones. (Credit: CSB)

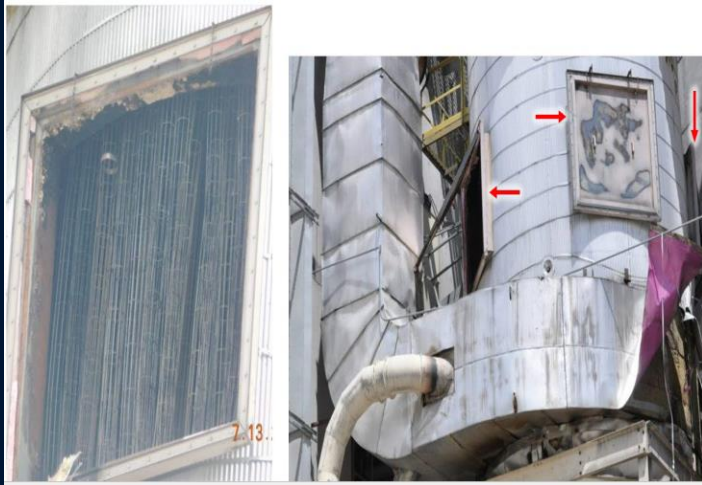
‘The CSB concludes that the deflagration that began in 1B propagated to the Dry Grit Filter..’

Dry Grit Filter damage. Internal damage (left). The filter socks were burned away, leaving only the metal cages. Deflagration vents (right, red arrows) stuck open and with burn damage. (Credit: Didion, annotations by CSB)

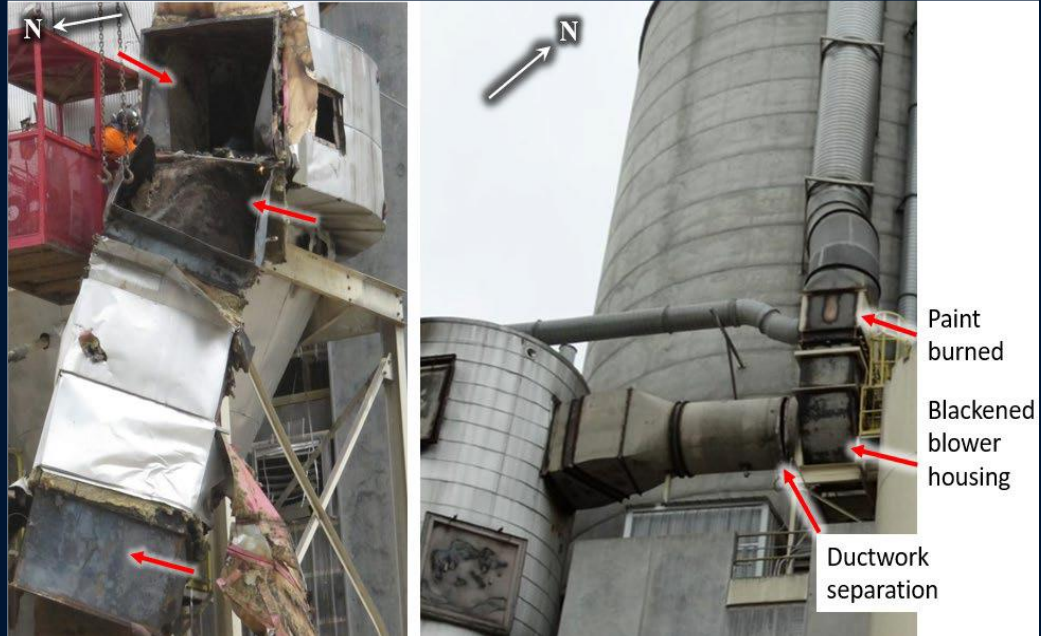
Examples of Dry Grit Filter ductwork and blower damage (red arrows). Inlet duct blackened (shown during demolition, left) and exhaust to atmosphere, including blower (right). (Credit: left, Didion with annotations by CSB; right, CSB)

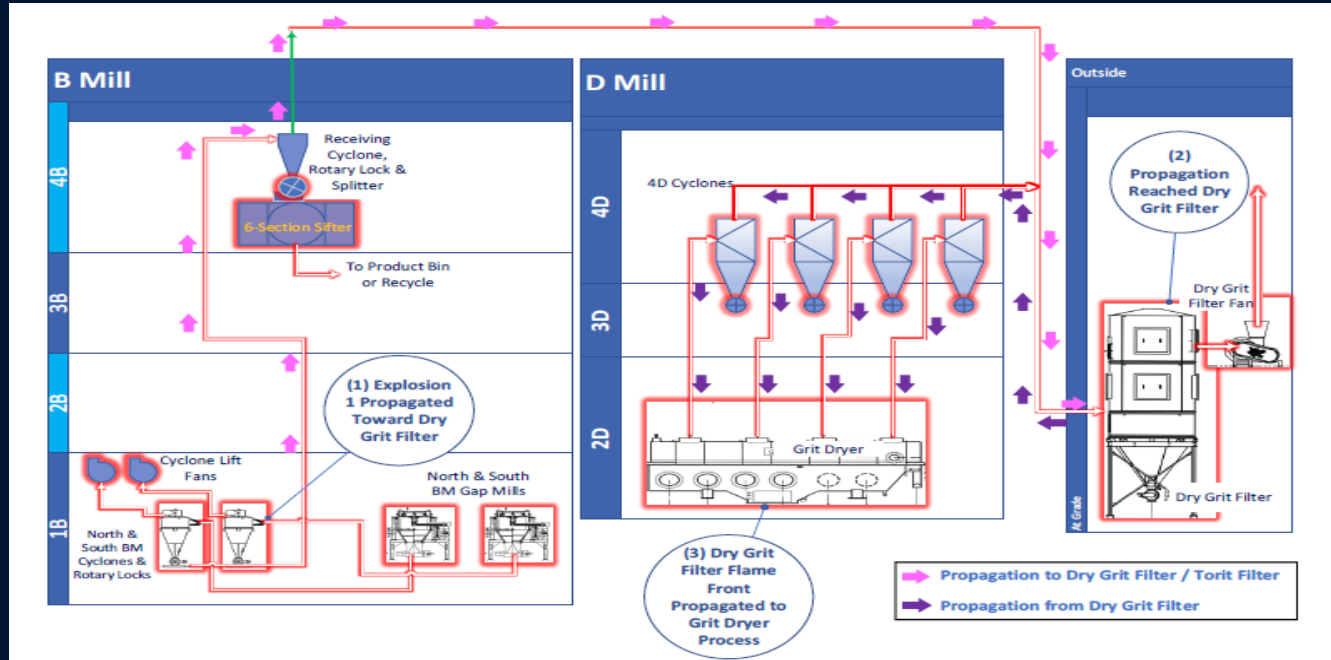
‘The CSB concludes that a deflagration in the Dry Grit Filter propagated to other previously uninvolved parts of Didion’s processes, which allowed explosions and fire to continue to spread throughout the mill processes..’

Potential path for propagation from 1B to Dry Grit Filter (pink arrows) to (simplified) Grit Dryer system (purple arrows). Known internal fire damage is highlighted red. (Credit: CSB)

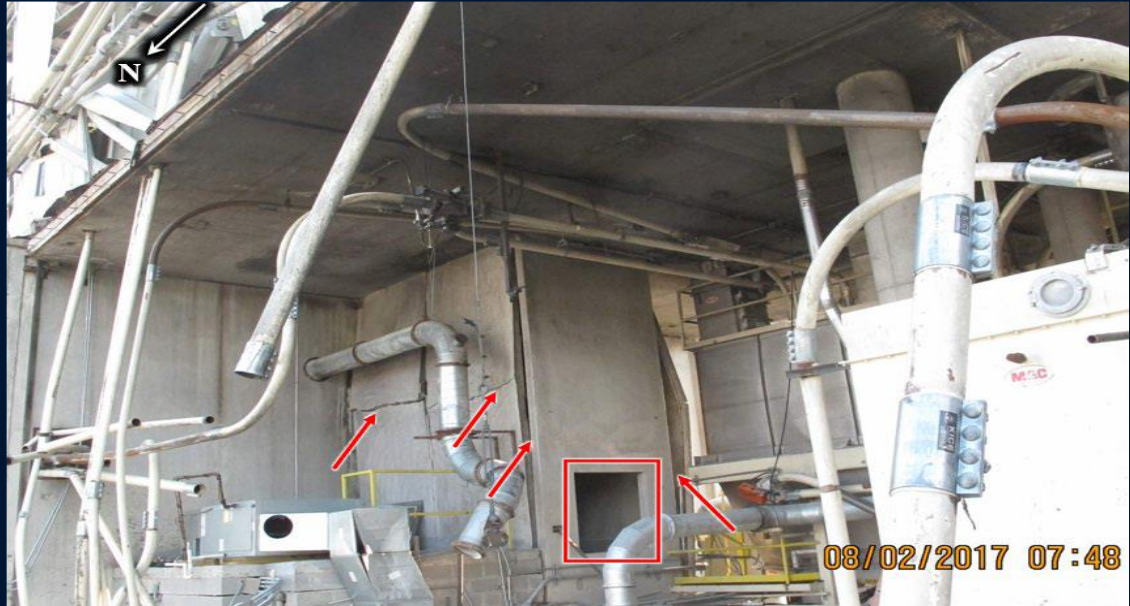
“The CSB concludes that the primary explosion in 1B and the ensuing propagations lofted fugitive dust and spread secondary explosions throughout the mill facility.”

- Process material blew out of the filter process piping and lofted into the air.
- Explosion directional analysis and building collapse analysis indicate that the air supply shafts between A Mill and B Mill allowed explosions to propagate upward from 1B throughout A Mill and B Mill.

4B air shaft damage (red arrows) and shaft opening into 4B (red box) in B Mill interior, pre-demolition. The 4B wall panels detached from the B Mill structure during the incident. (Credit: Didion, annotations by CSB)

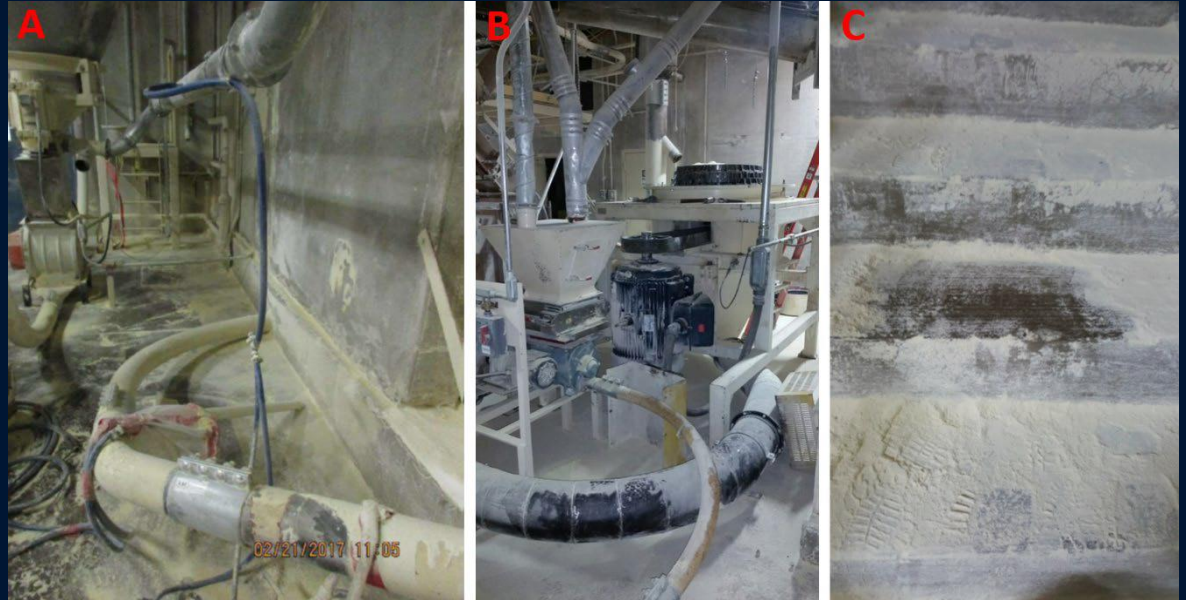
The CSB concludes that Didion's Monthly Sanitation Inspection had ineffective housekeeping practices and allowed unacceptable levels of dust layer. As a result, secondary dust explosions fueled by fugitive dust led to building collapse and multiple injuries and fatalities.

- The housekeeping program was the site's sanitation program.
- Employees performing the inspections did not have a clear understanding of dust accumulation risk in the Monthly Sanitation Inspections- the only mention of OSHA's 1/8 inch at priority.
- Master sanitation relied on HACCP (Hazard Analysis and Critical control Points)
- Didion's HACCP did not contain any analyses of combustible dust hazards or scenarios

Examples of fugitive dust accumulations, (A) approximately three months before the incident, (B) approximately two weeks before the incident, and (C) less than 24 hours before the incident.
