SCIC 2025:

Fire Statistics and Case Studies

CPT Firdaus Zulkfle
Incident Analyst
Fire Investigation Unit

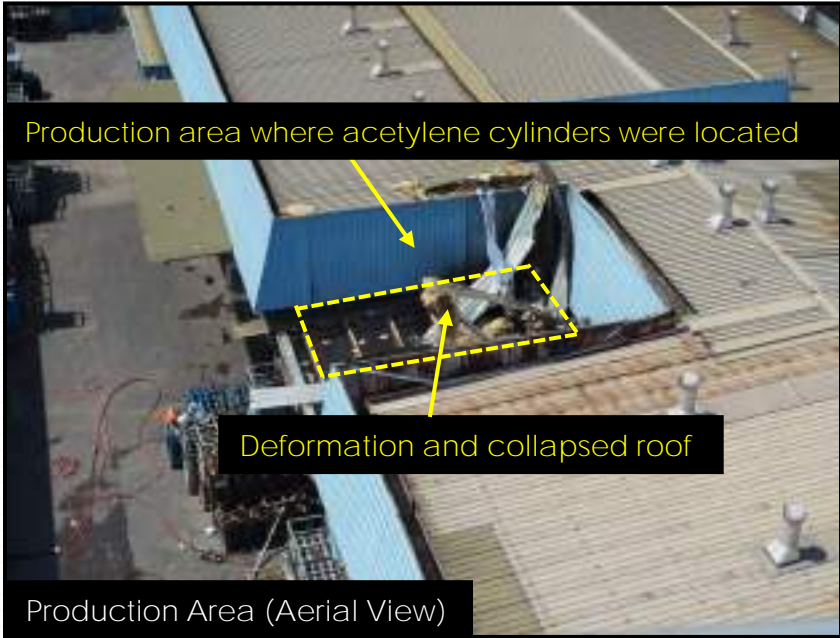
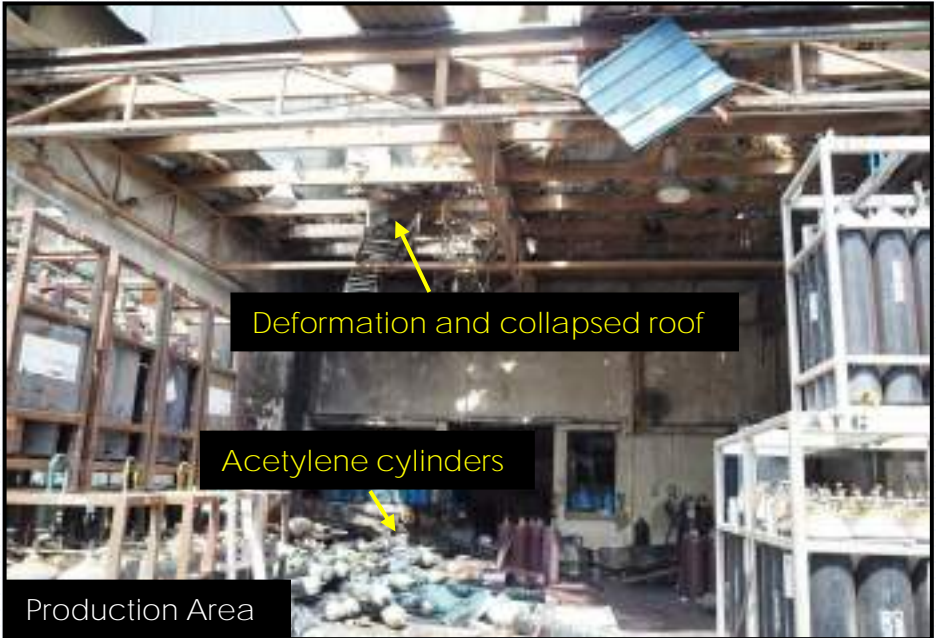
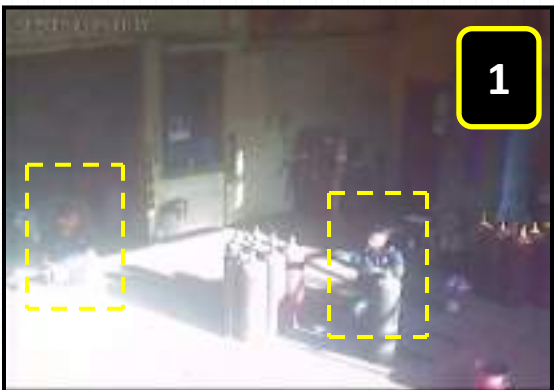
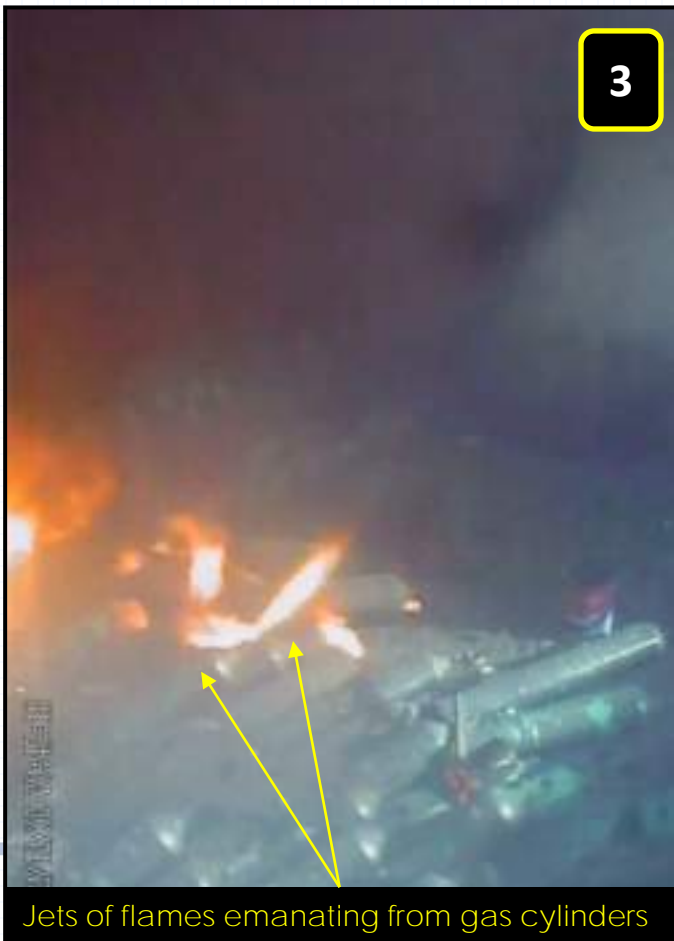
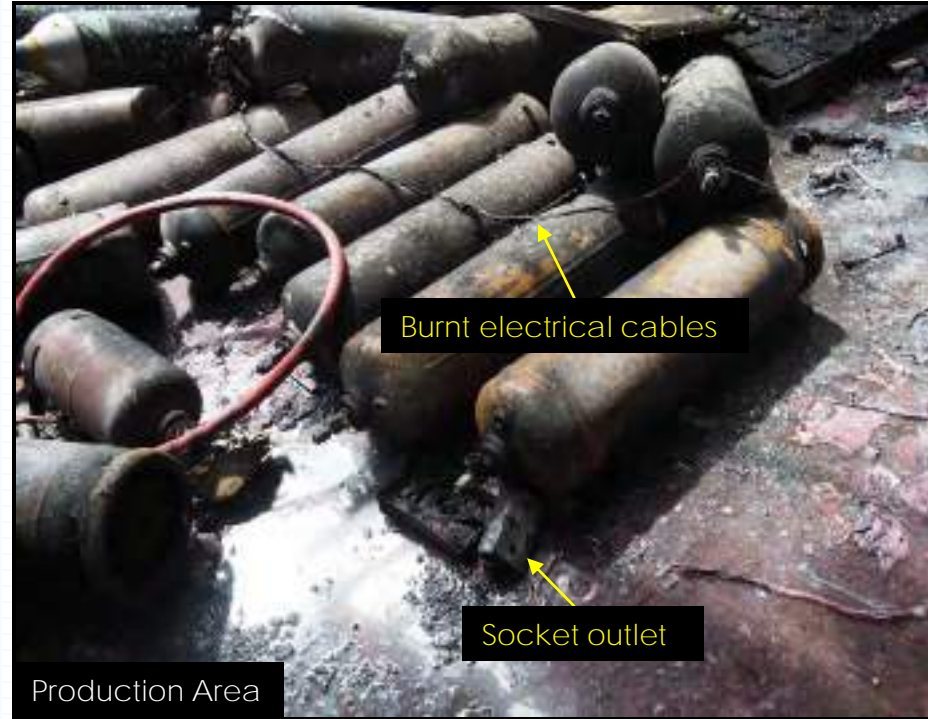
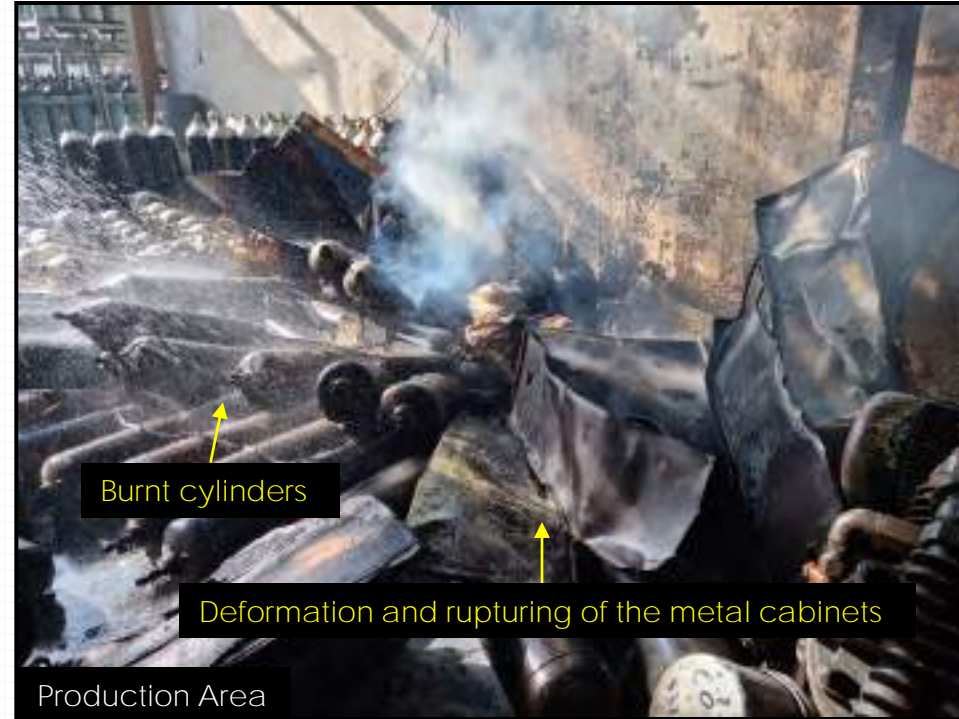
- Fire involved:
 - Gas cylinders in the production area of a gas filling company
 - Company manufactures industrial gases
- Method of extinguishment:
 - Fire extinguished by SCDF using 1 x 38mm water jet
- Cause of fire:
 - Point of ignition was traced to a wiring / connection where a localized and distinct arc bead was found
 - Arcing had likely served as an ignition source and caused the fire outbreak in the presence of a flammable environment (i.e., acetylene gas)
 - Circumstances that led to an electrical anomaly may include, but is not limited to:
 - wear and tear, short circuiting, loose connections, or inherent defects of the electrical sockets, wirings or/and components, which subsequently led to ignition of accumulated acetylene gas
- Injuries:
 - 1 x casualty sustained extensive cutaneous burns and succumbed to his injuries

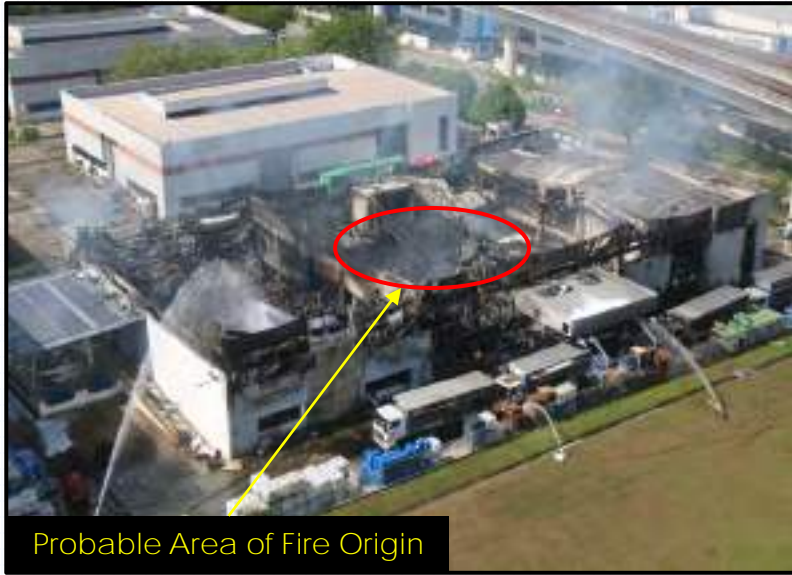
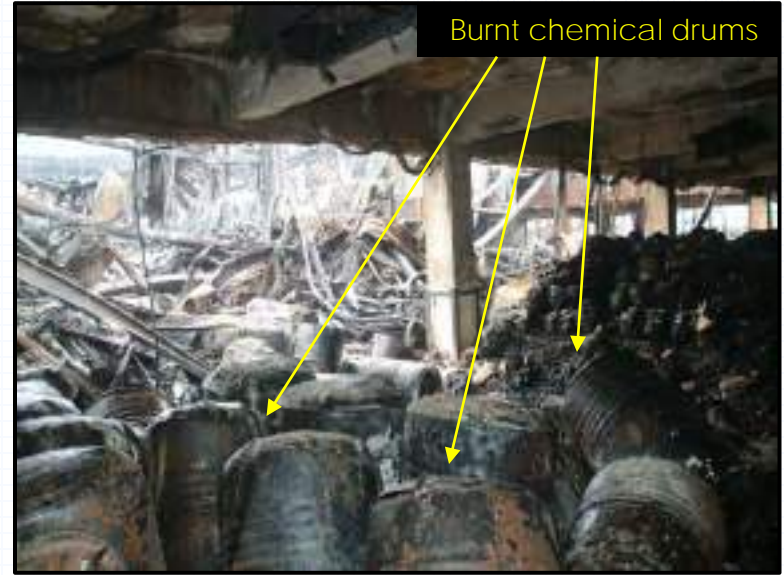
- Multiple chemicals including flammable liquids and solids were stored in warehouse
 - Fire originated from middle section of warehouse
 - Multiple hypotheses:

1. Electrical origin at reach truck and/or its connected charging accessories, as severe oxidation damage was observed on these appliances. Presence of round and smooth beads were also found at localized points on various electrical components of the reach truck's charging accessories

2. Spontaneous combustion from stored chemicals, as chemicals with self-heating potential and stored within the middle section of the warehouse included but were not limited to Hydroxyethyl Methacrylate (HEMA) and Ethyleneglycol Dimethacrylate(EDMA)

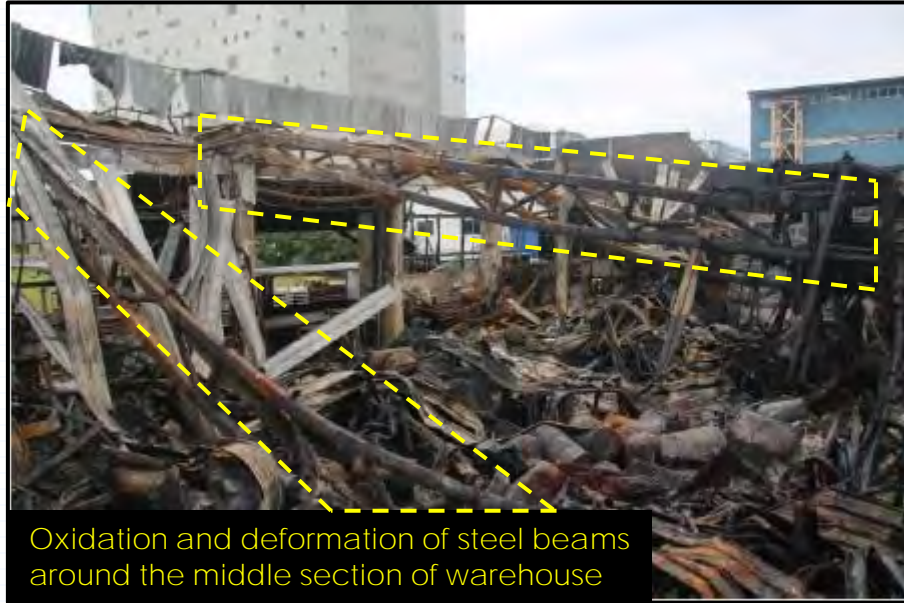
Oxidation and deformation of steel beams around the middle section of warehouse

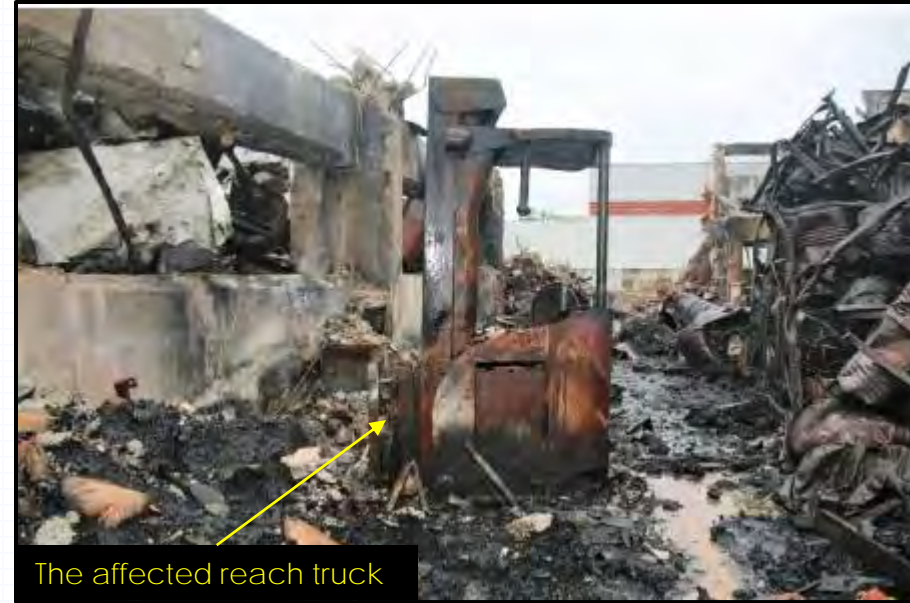
The affected reach truck

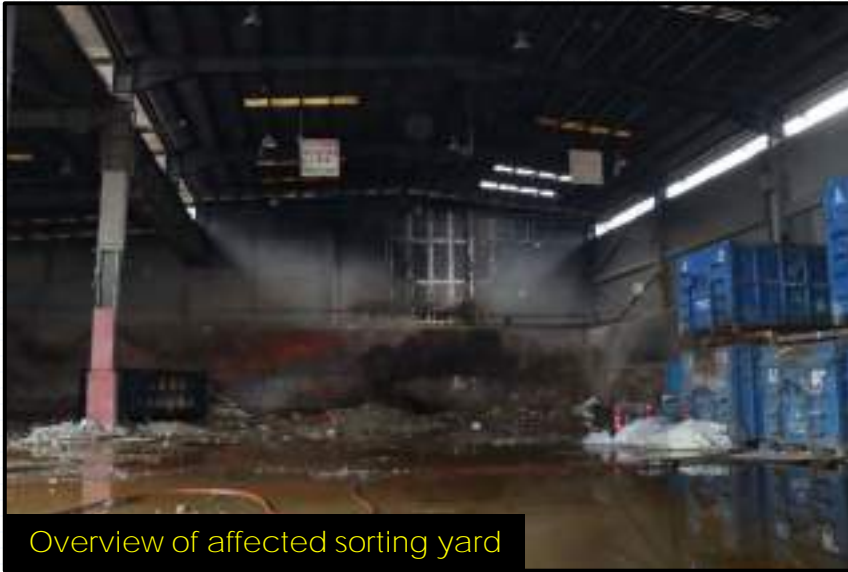
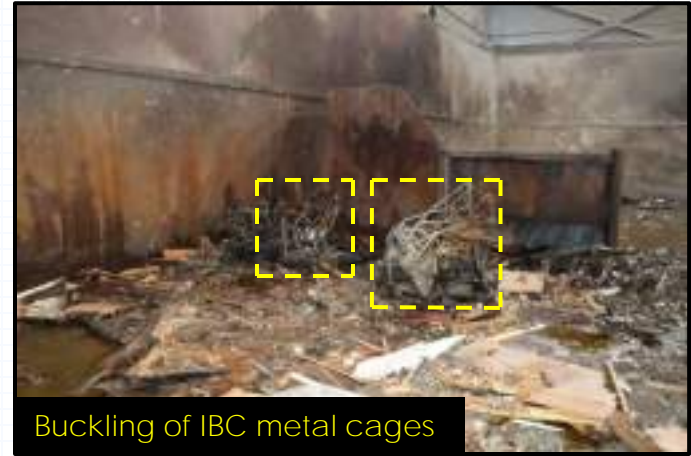
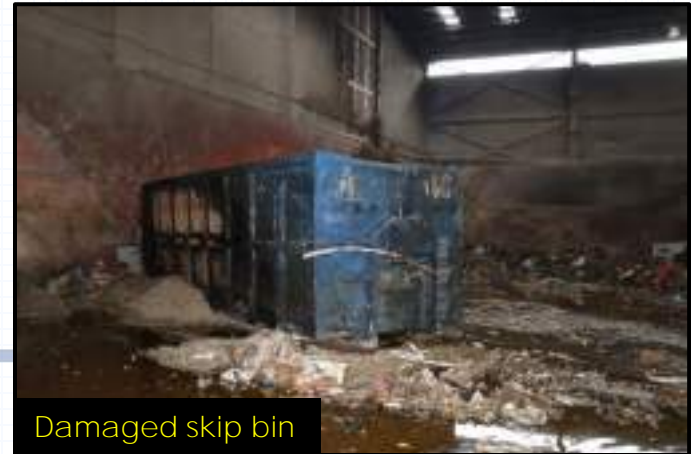
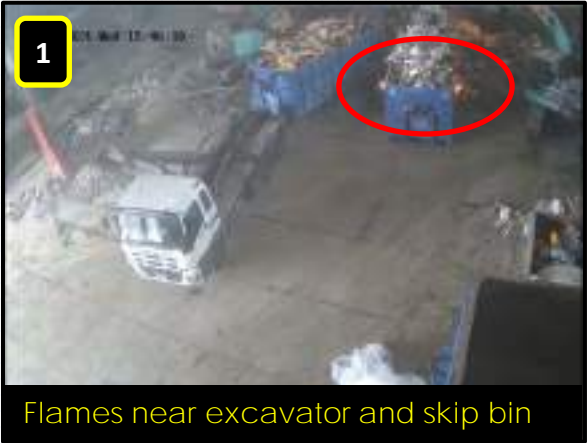
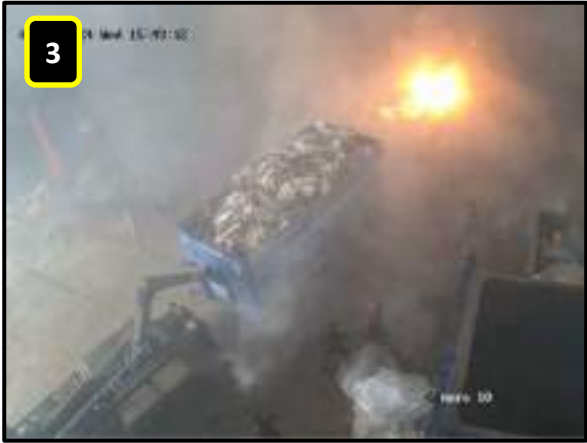
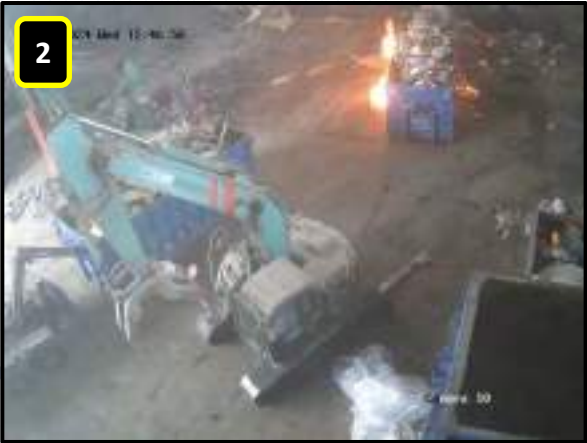
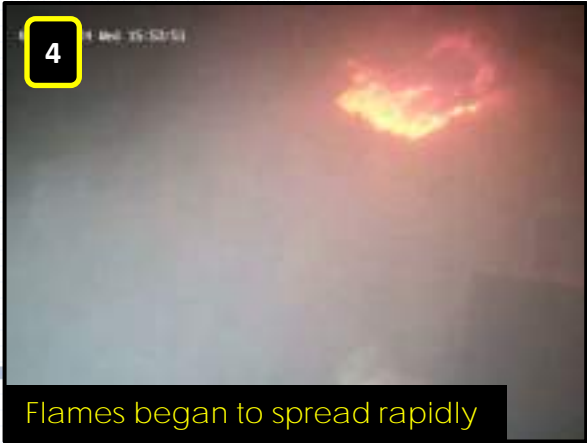
- Method of extinguishment:
 - Fire extinguished by SCDF using 1 x 38mm water jet
- Cause of fire:
 - The most probable cause of fire was believed to be **accidental due to sparks/frictional heat** from the mechanical movement of an excavator's bucket

- An IBC containing untreated water as well as presence of isopropyl alcohol and other flammable liquids leaked onto the floor of the sorting yard
 - Frictional heat between excavator bucket and ground caused a spark which possibly ignited the isopropyl alcohol that leaked from the IBC

- Safe Management of Waste Materials:
 - For more information, do refer to NEA's website: https://www.nea.gov.sg/docs/default-source/our-services/waste-management/20221223_advisory-on-safe-management-of-waste-materials.pdf
