# **SCIC 2023: Fire Statistics and Case Studies**

24 November 2023

*LTA Vivien Sim, Incident Analyst, SCDF*

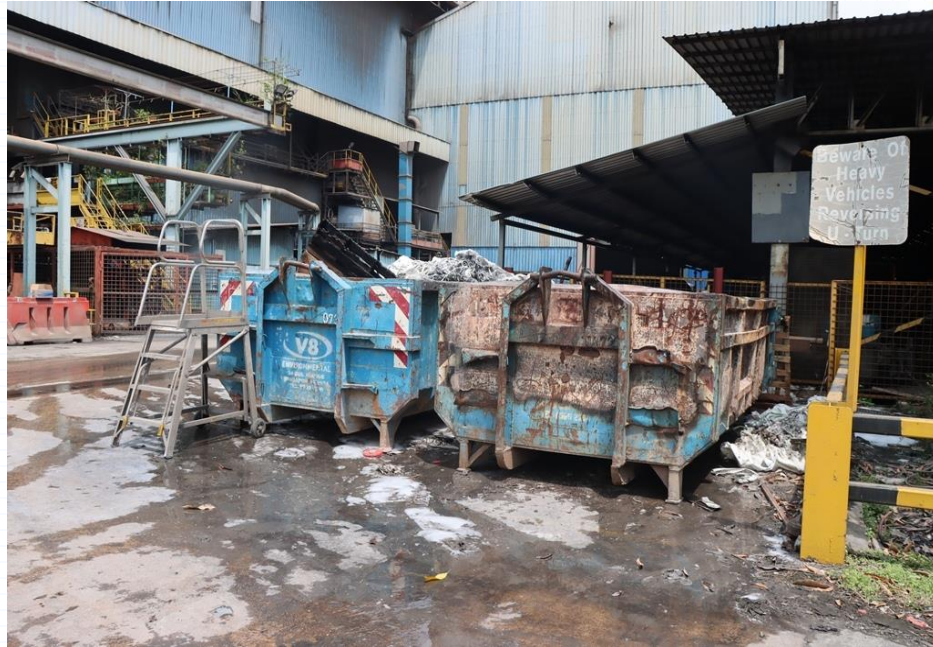
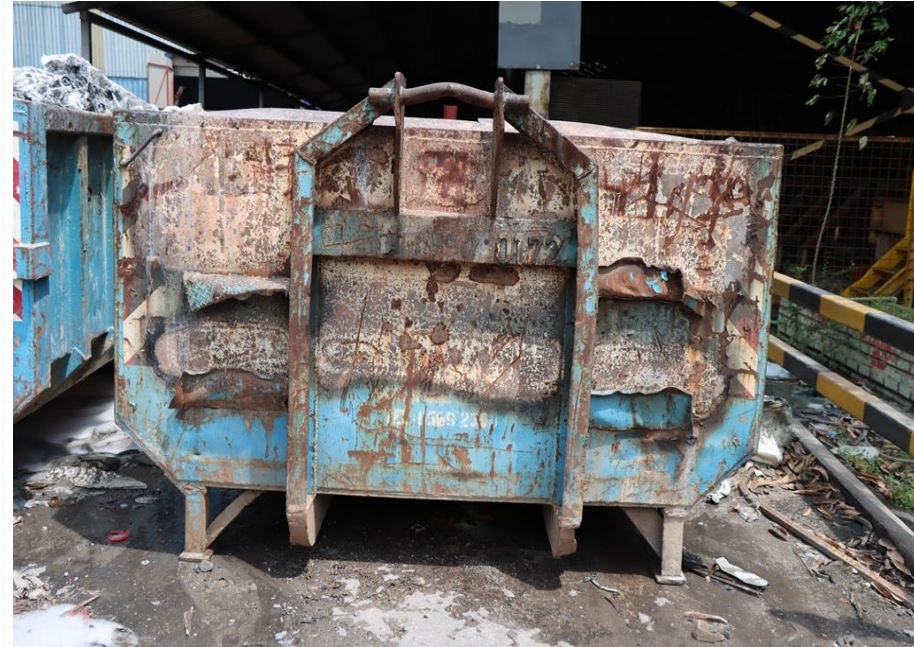
- Fire originated from discarded industrial bags inside the waste container.
  - Presence of Calcium Hydroxide, a by-product of Calcium Oxide with rainwater.
  - Fire occurred as a result of exothermic reaction from calcium oxide ( $\text{CaO}$ ), also known as quicklime
- The fire affected the contents in the waste container and spread to the waste container beside it.

Photos showing the area of fire origin at the waste container.

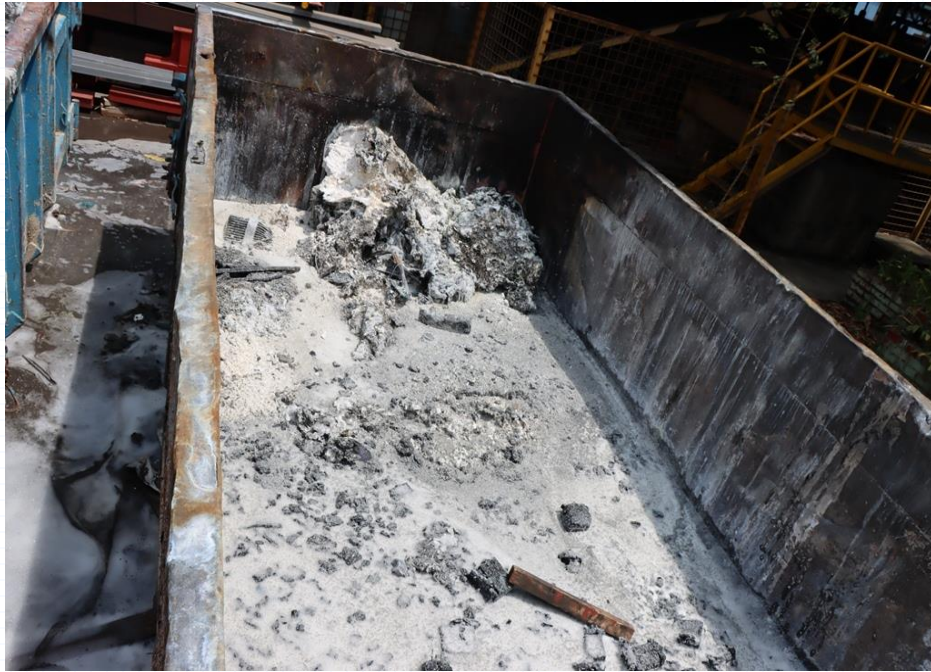
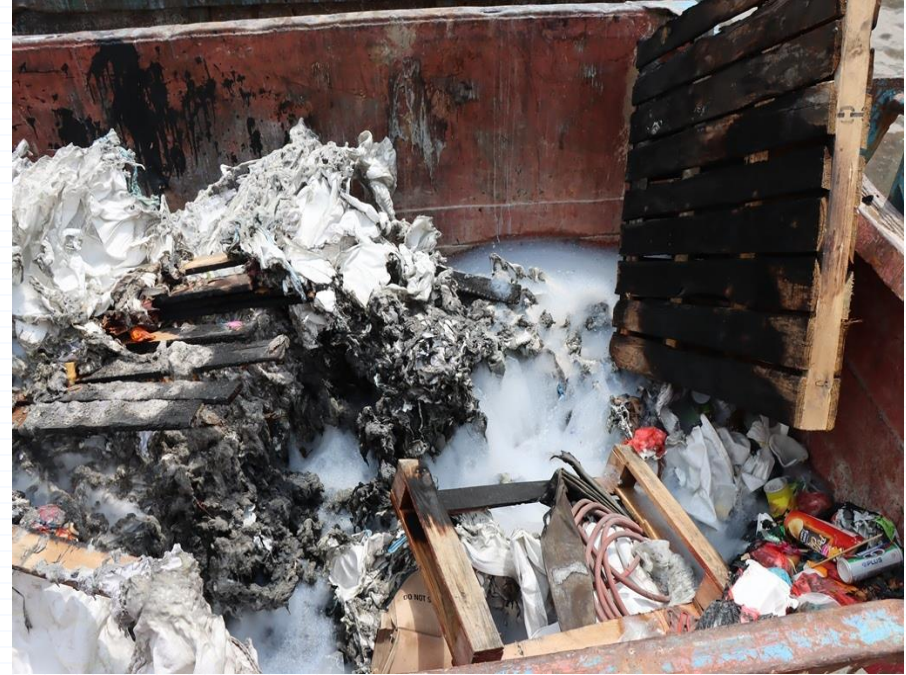
Photos showing the damages inside the waste container.

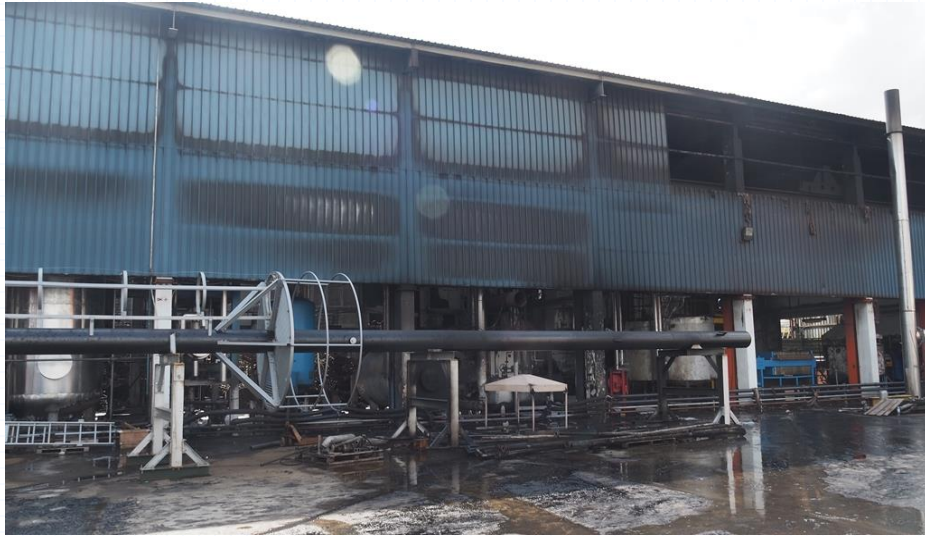
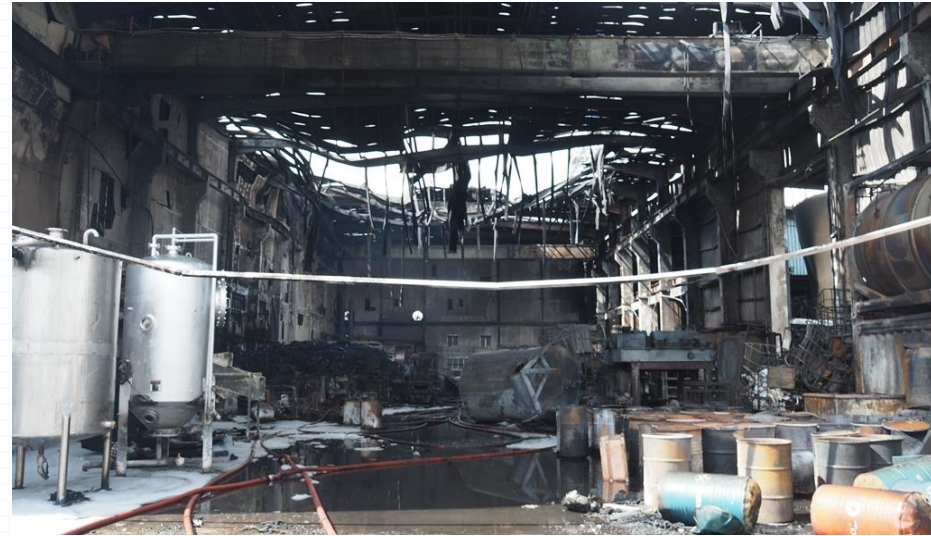
- Fire occurred during the oil transfer between the ISO tank and skid tank
  - Static electric discharge is the most likely cause of ignition
  - Oil, carbon pile, car filters, machineries and forklift were ignition fuels
  - Workers did not use earthing cables since the building structures have their own earthing points (lightning protection system)
- The fire affected the contents of warehouse

Photos showing the extent of damage to the warehouse.

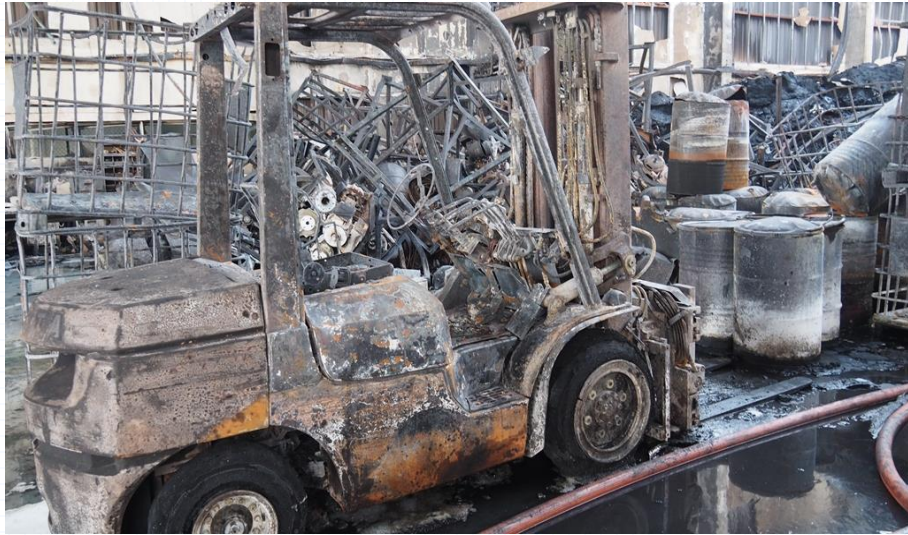
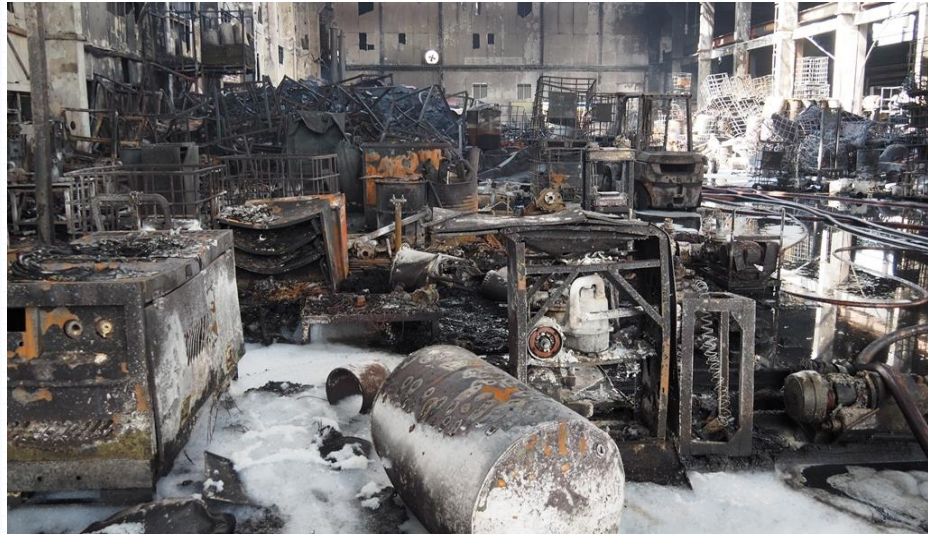
Photos showing the machineries, carbon pile and interior walls of the warehouse sustained fire damages.

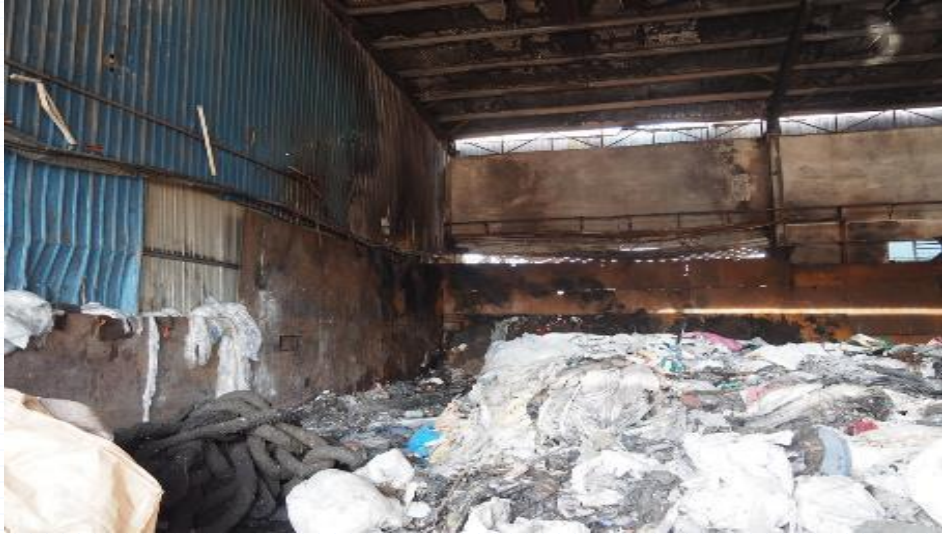
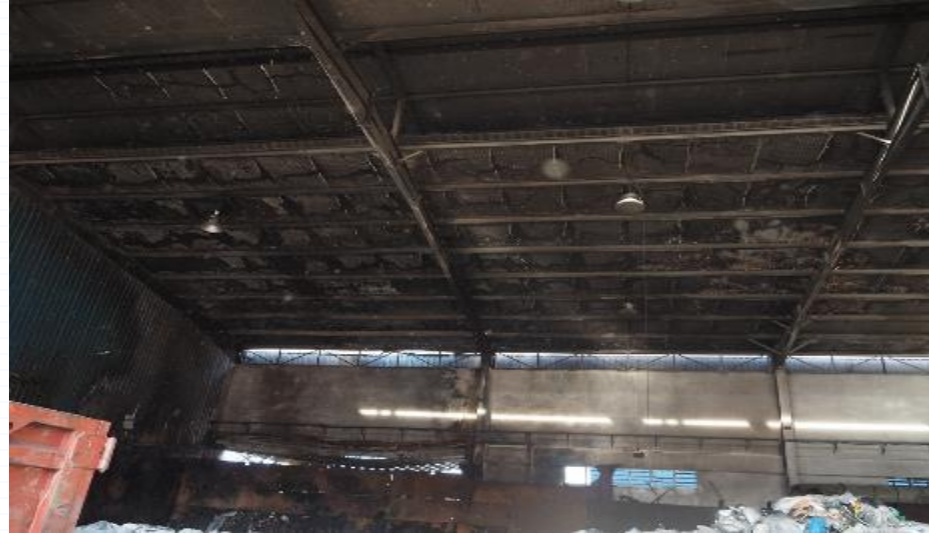
- Fire occurred as a result of electrical anomaly at the electrical fixtures or spontaneous combustion of the construction waste
  - Electrical fixtures (exhaust fan, flood light) in the warehouse malfunctioned since last year. Although electrical appliances were not in use, company did not engage electricians to cut off electrical supply. Electrical wiring of warehouse was last maintained 23 years ago.
  - Waste pile might include e-waste or other chemical waste that was undetected.
  - Construction waste (steel, metal, plastic, wood, etc) stored in the warehouse were the ignition fuels.
- The fire affected the contents of warehouse

Photos showing the extent of damage to the production area.

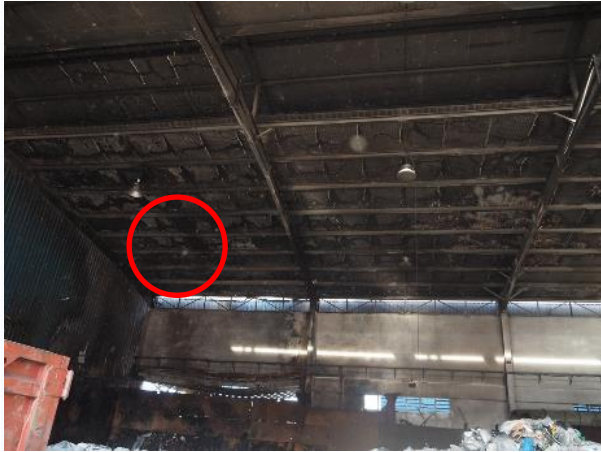
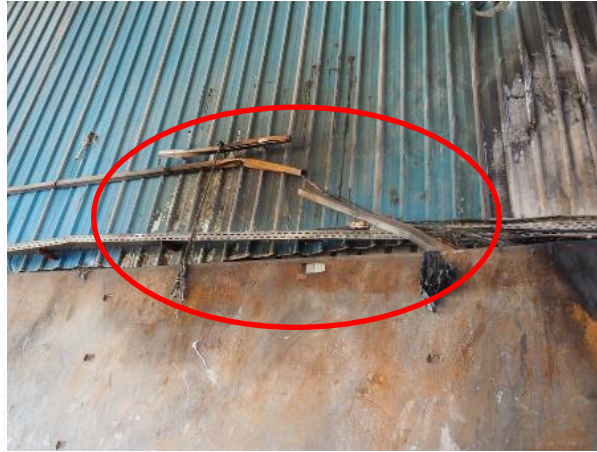
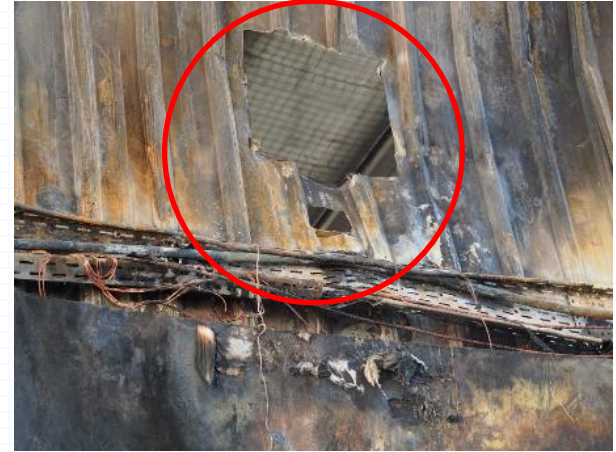
Photos showing the damaged electrical fixtures (L-R: Missing bay light, damaged electrical fixtures, missing exhaust fan).
