IMPORTANCE OF DESIGN FOR SAFETY TOWARDS VISION ZERO

Combustible Dust Explosion Seminar
Singapore Chemical Industry Council, SCIC
13 May 2026, SCIC Training Room

Importance of Design for Safety towards Vision Zero

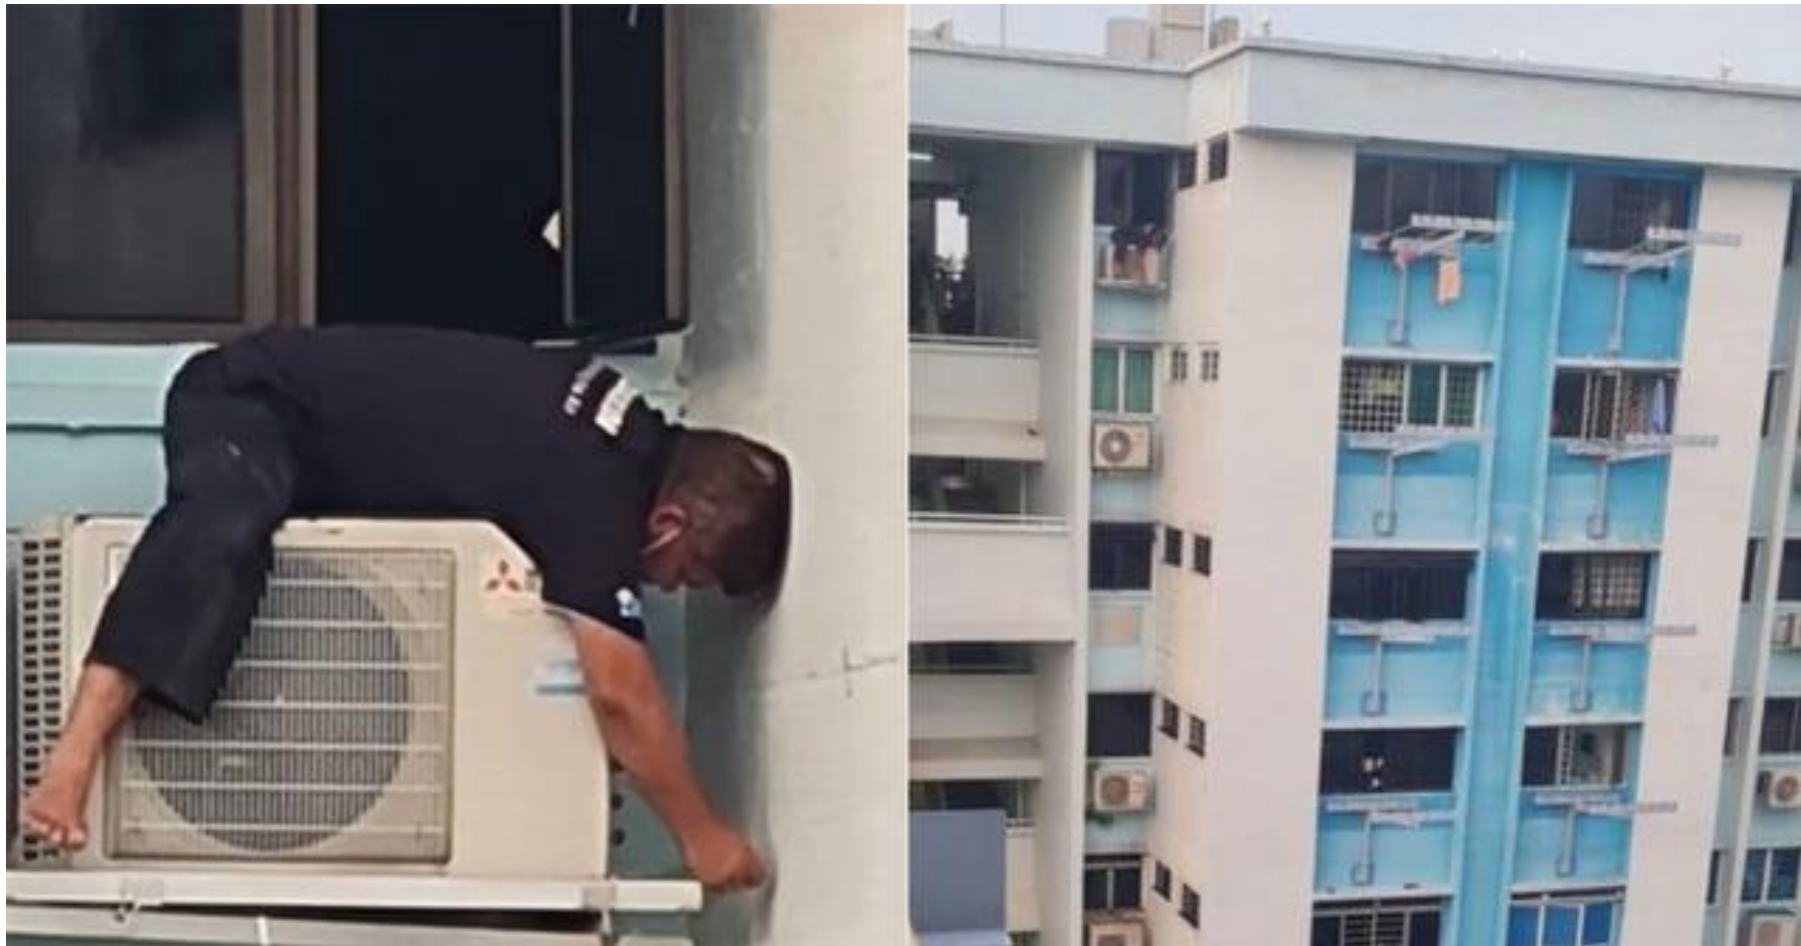
Air-con repairman dangles outside 12th storey HDB flat **without harness, risks life for few hundred dollars**

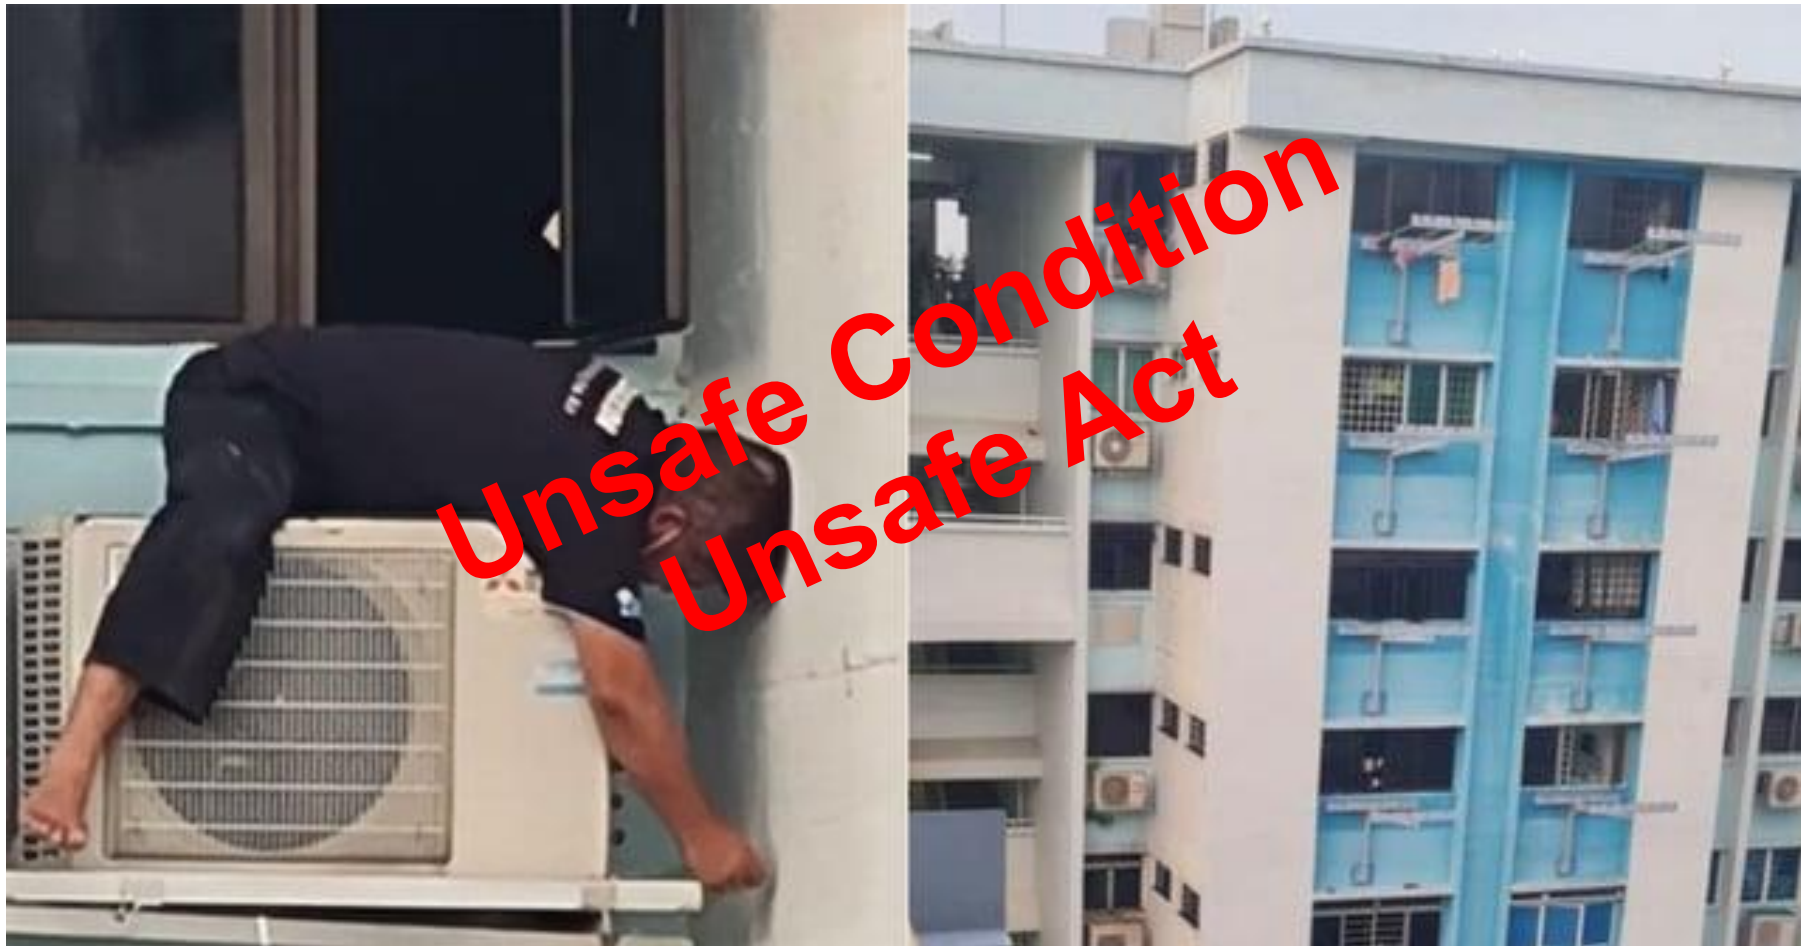
Air-con repairman dangles outside 12th storey HDB flat **without harness, risks life for few hundred dollars**

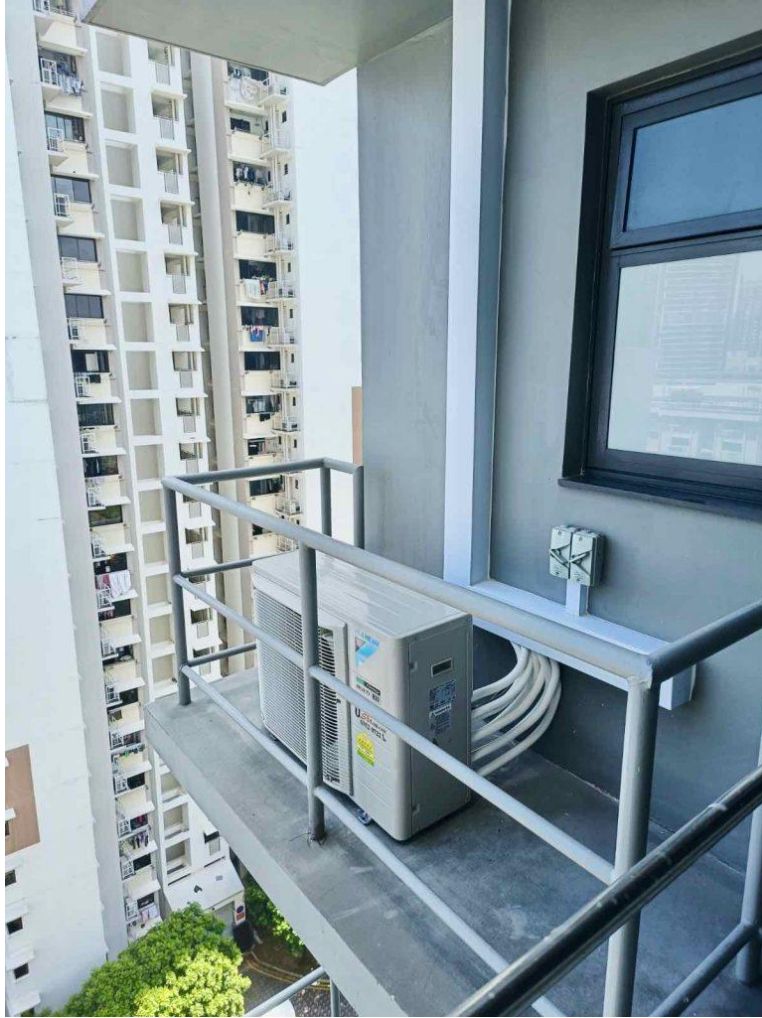
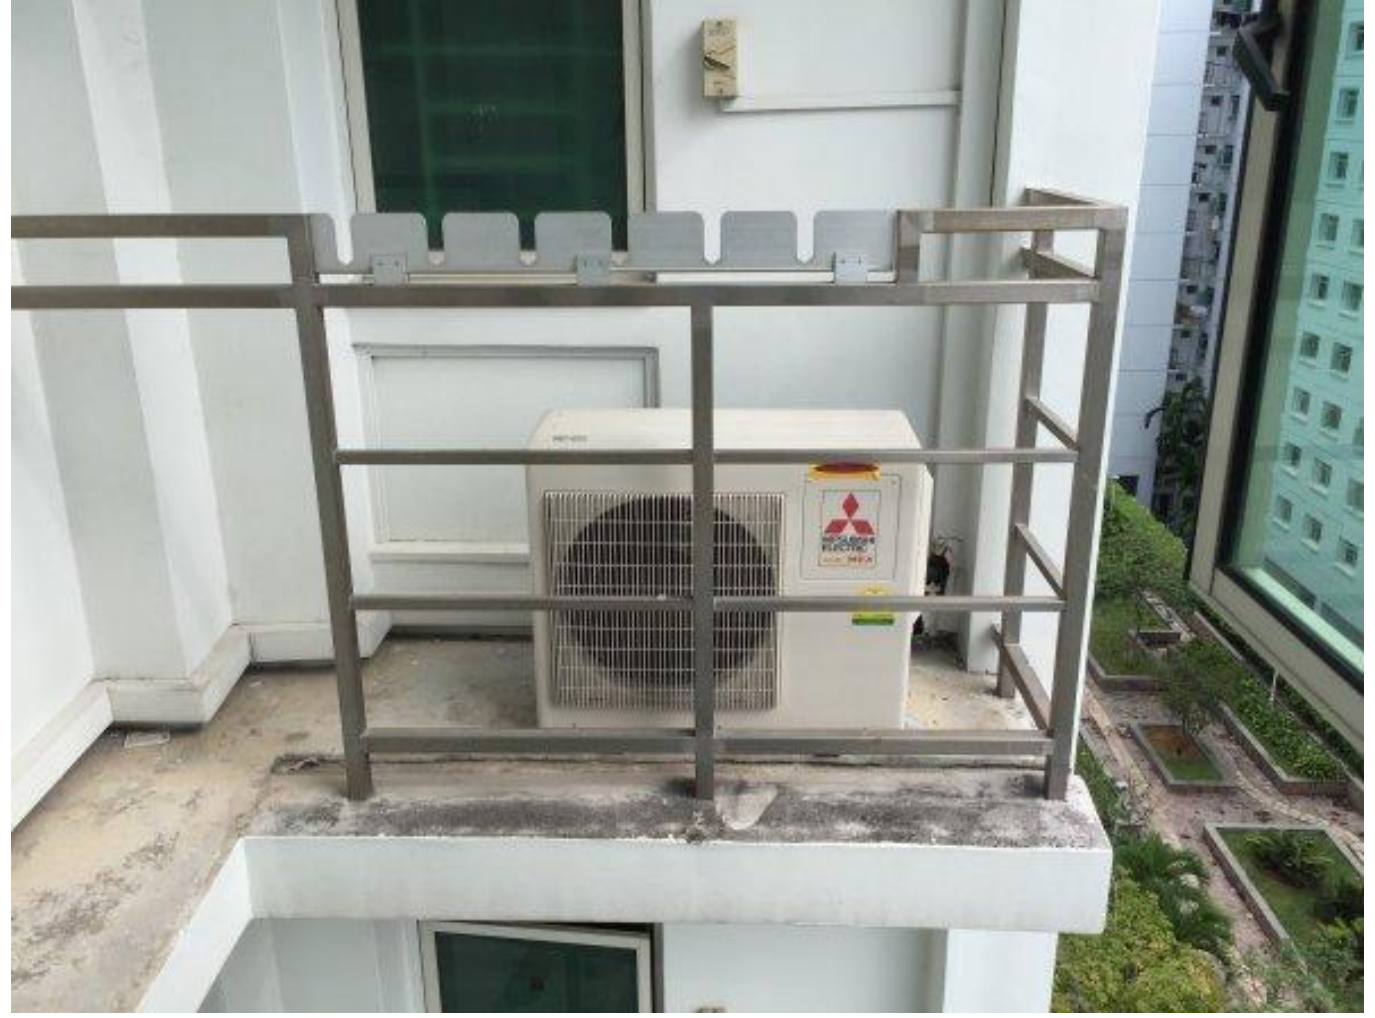
Safer Design – Purpose Built Ledge for Air-con Condensing Unit

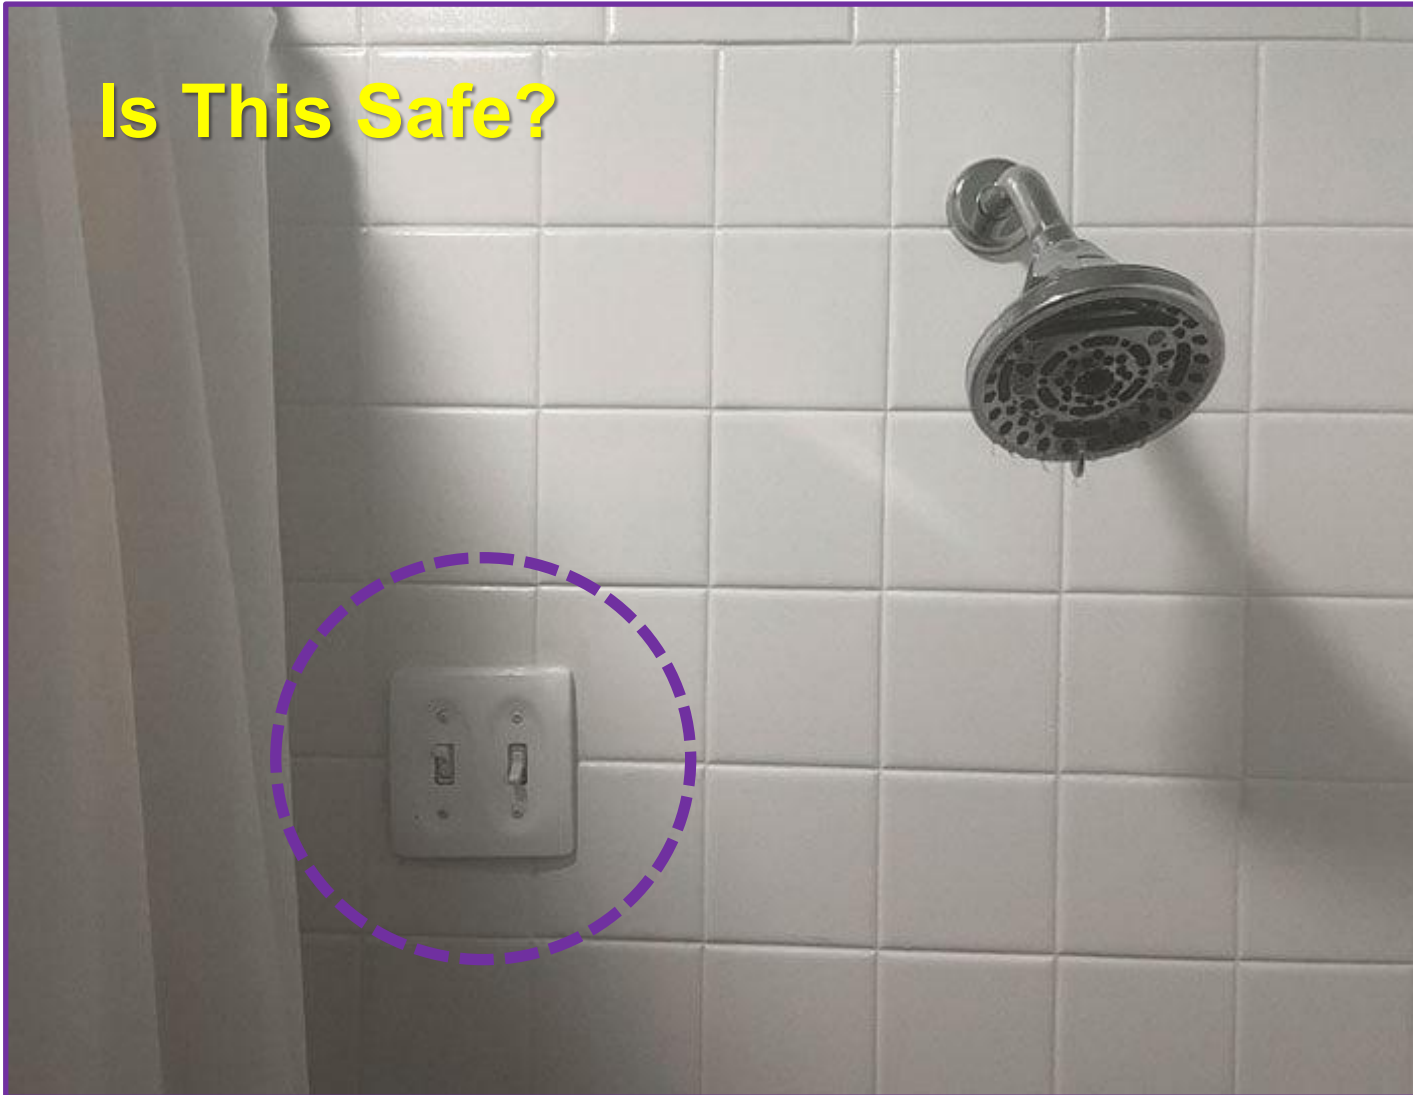
Switches are **less than a Foot** away from the Shower and located inside the **Curtain!**

Switches are less than a Foot away from the Shower and located inside the Curtain!

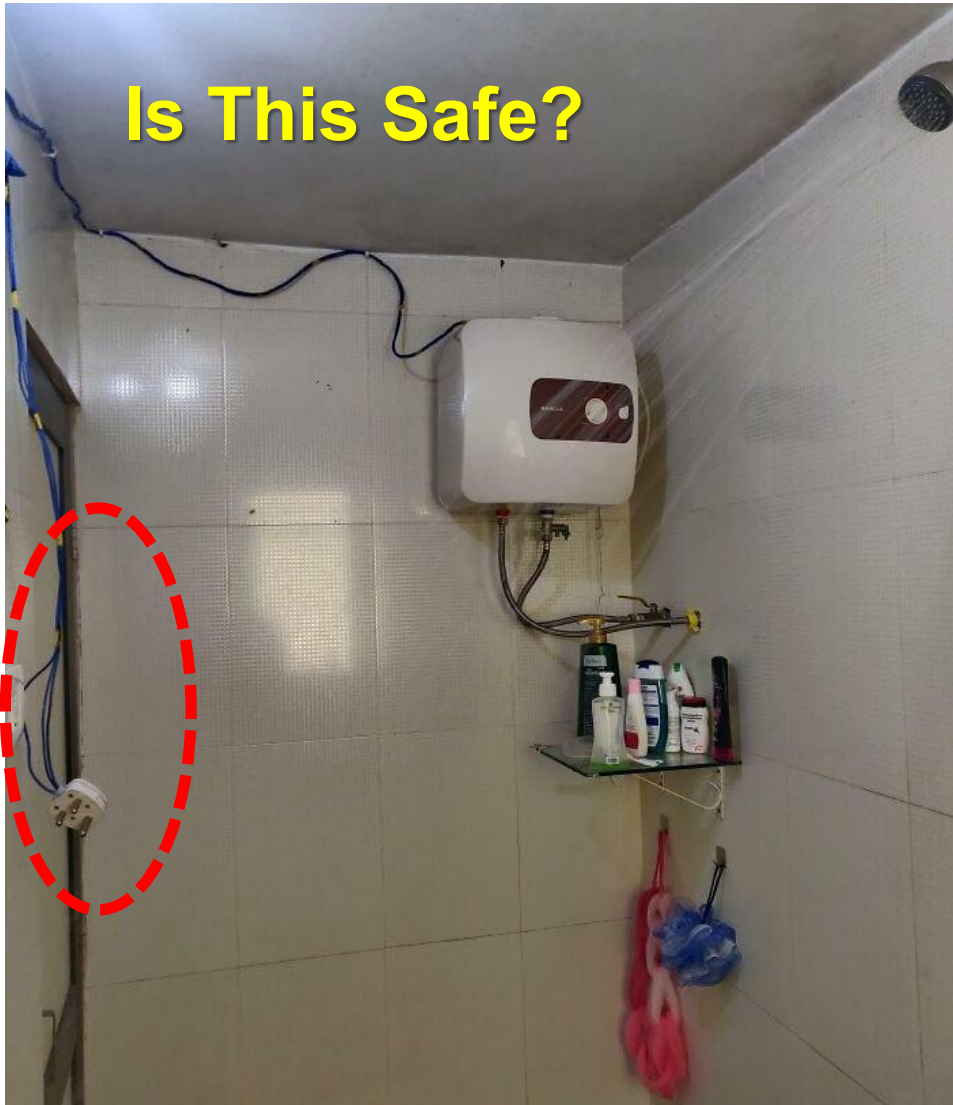
What went wrong?

1. This Power Plug is connected Exactly on the Opposite Side of The Shower
2. Wrong Power Switch is used

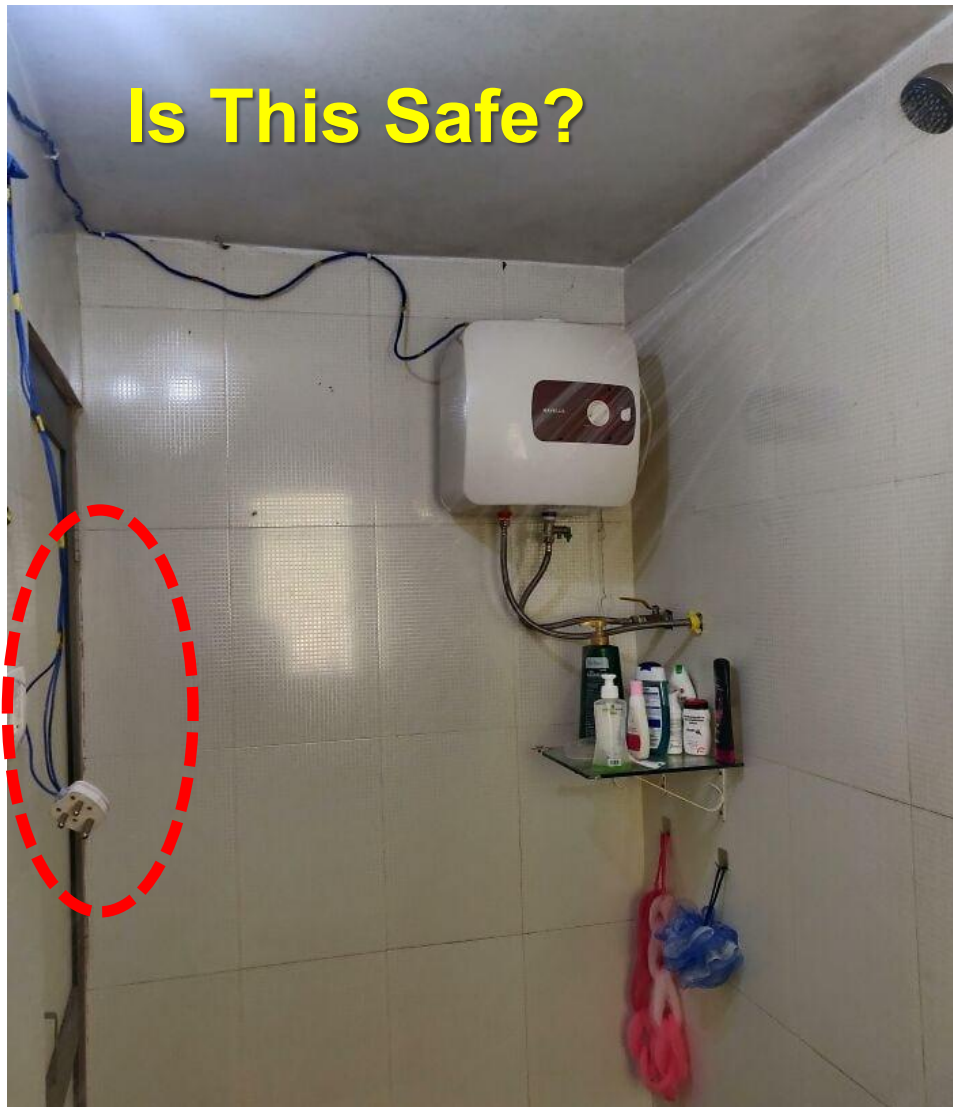
Accident involved water heater that had been installed in unsafe manner

When investigators disassembled the water heater's three-pin plug, they found that the neutral and earth cables had fused together.

This caused the current to flow back to a heating tank in the water heater, energising a metallic hose connected to the tank.

But when investigators checked the flat, they found the residual current circuit breaker (RCCB) did not protect the main electricity circuit for the whole unit. Only the utility room was protected.

Senior associate engineer Goh Chin Fong from the Energy Market Authority testified in March that the heater should have been connected directly to a double-pole switch instead of a wall plug.

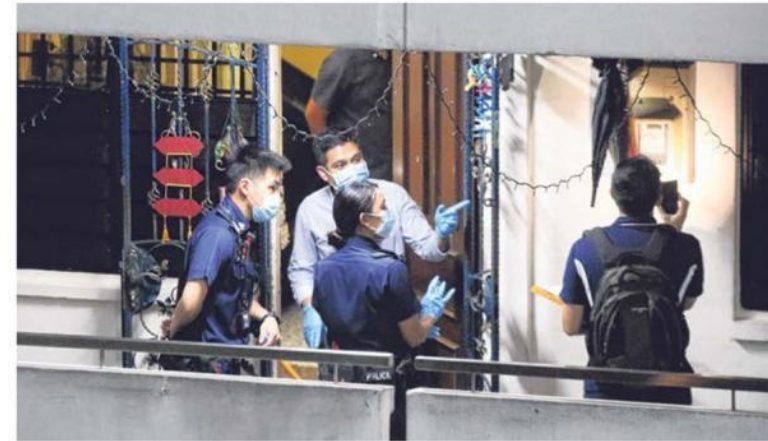
The accident, which claimed the lives of an elderly couple and their son, took place in the couple's flat in Jurong in December 2020. When investigators checked the flat after the accident, they found that the residual current circuit breaker did not protect the main electricity circuit for the whole unit, but only the utility room. PHOTO: LIANHE ZAOBAO

A double-pole switch is safer as the cables are spaced farther apart, minimising the risk of the cables fusing together.

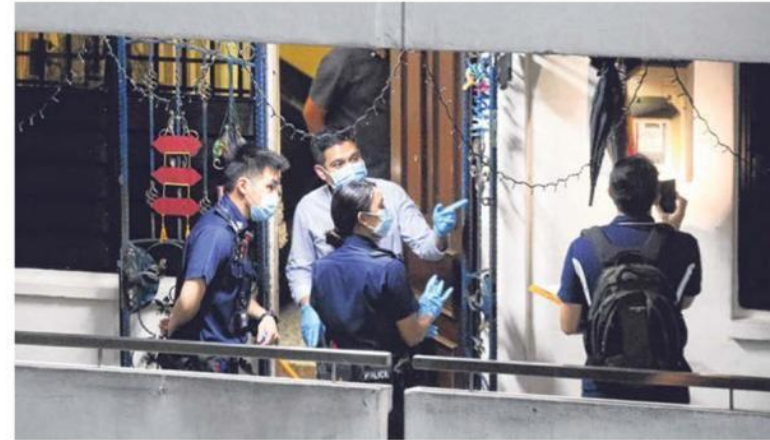
The accident, which claimed the lives of an elderly couple and their son, took place in the couple's flat in Jurong in December 2020. When investigators checked the flat after the accident, they found that the residual current circuit breaker did not

three-pin plug could have fused together because of overloading.

But when investigators checked the flat, they found the residual current circuit breaker (RCCB) did not protect the main electricity circuit for the whole unit. Only the utility room was protected.

**EMA on Water Heater Safety:
To replace 3-Pin Plug to Double-Pole Switch**

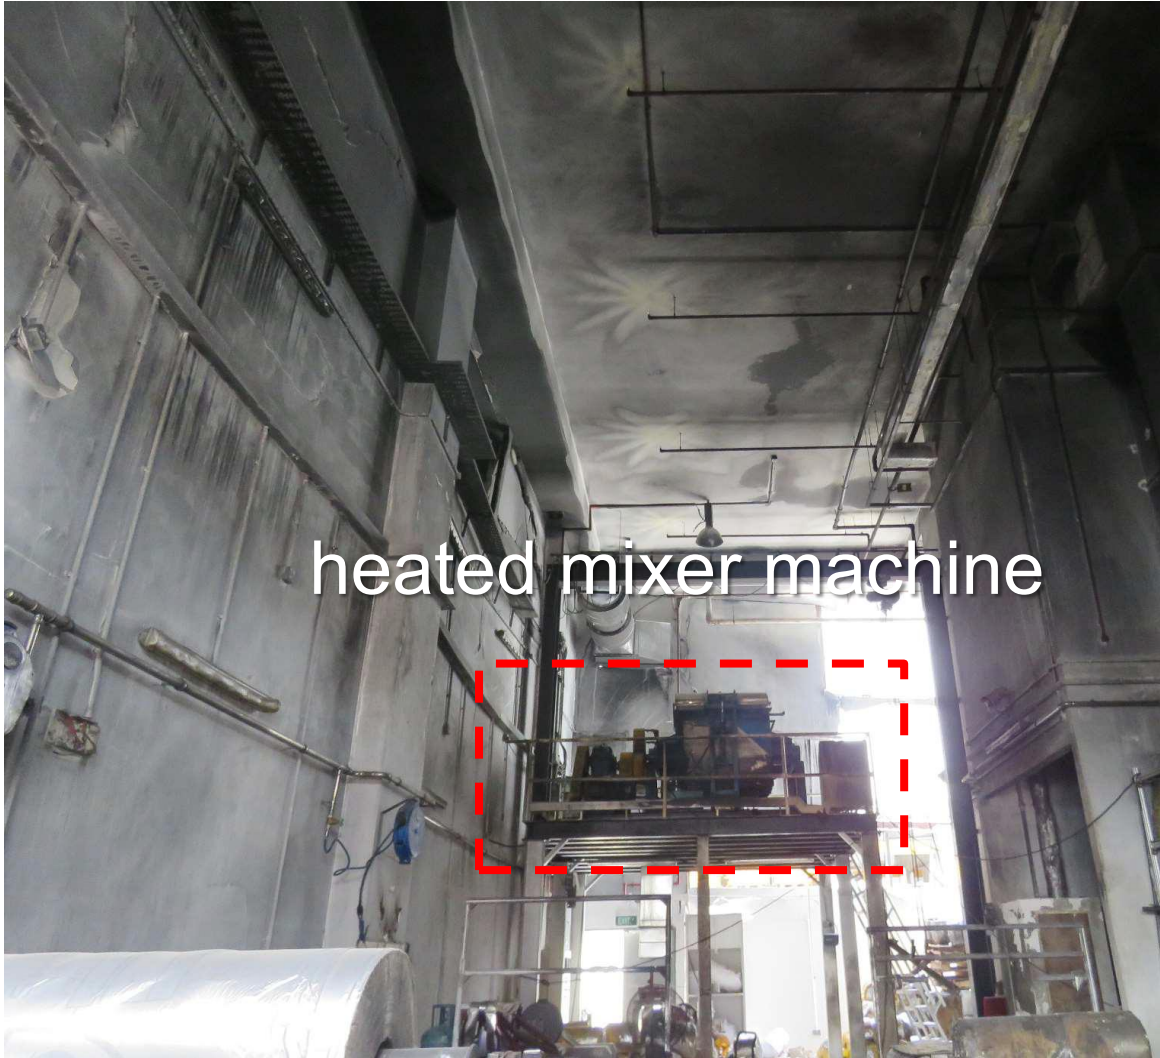
The mixer machine that exploded

The machine – which features a mixing container surrounded by a heated jacket of oil – is used to create a clay-like material used for fire protection in buildings.

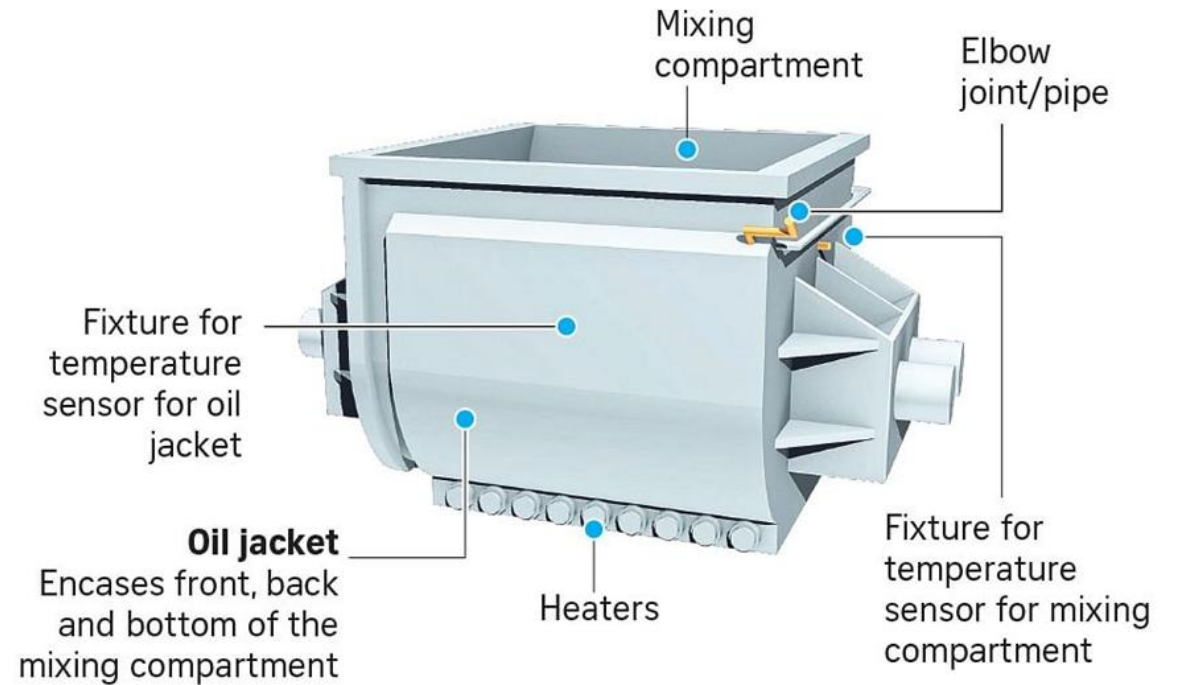
Temperature sensor not sensing oil temperature inside jacket

1 **Temperature sensor was not inserted to oil jacket** to monitor (and “control”) within safe limits, i.e. below oil boiling point so as to minimise oil vapour generation in jacket. The only one temperature sensor used at mixer chamber is not representative of oil temperature

3 There was no proper means to ascertain minimum thermic oil level required before commencement of operations. Insufficient oil level / without submerging heater elements not only resulted in inefficient heating of oil, but also overheating of heaters

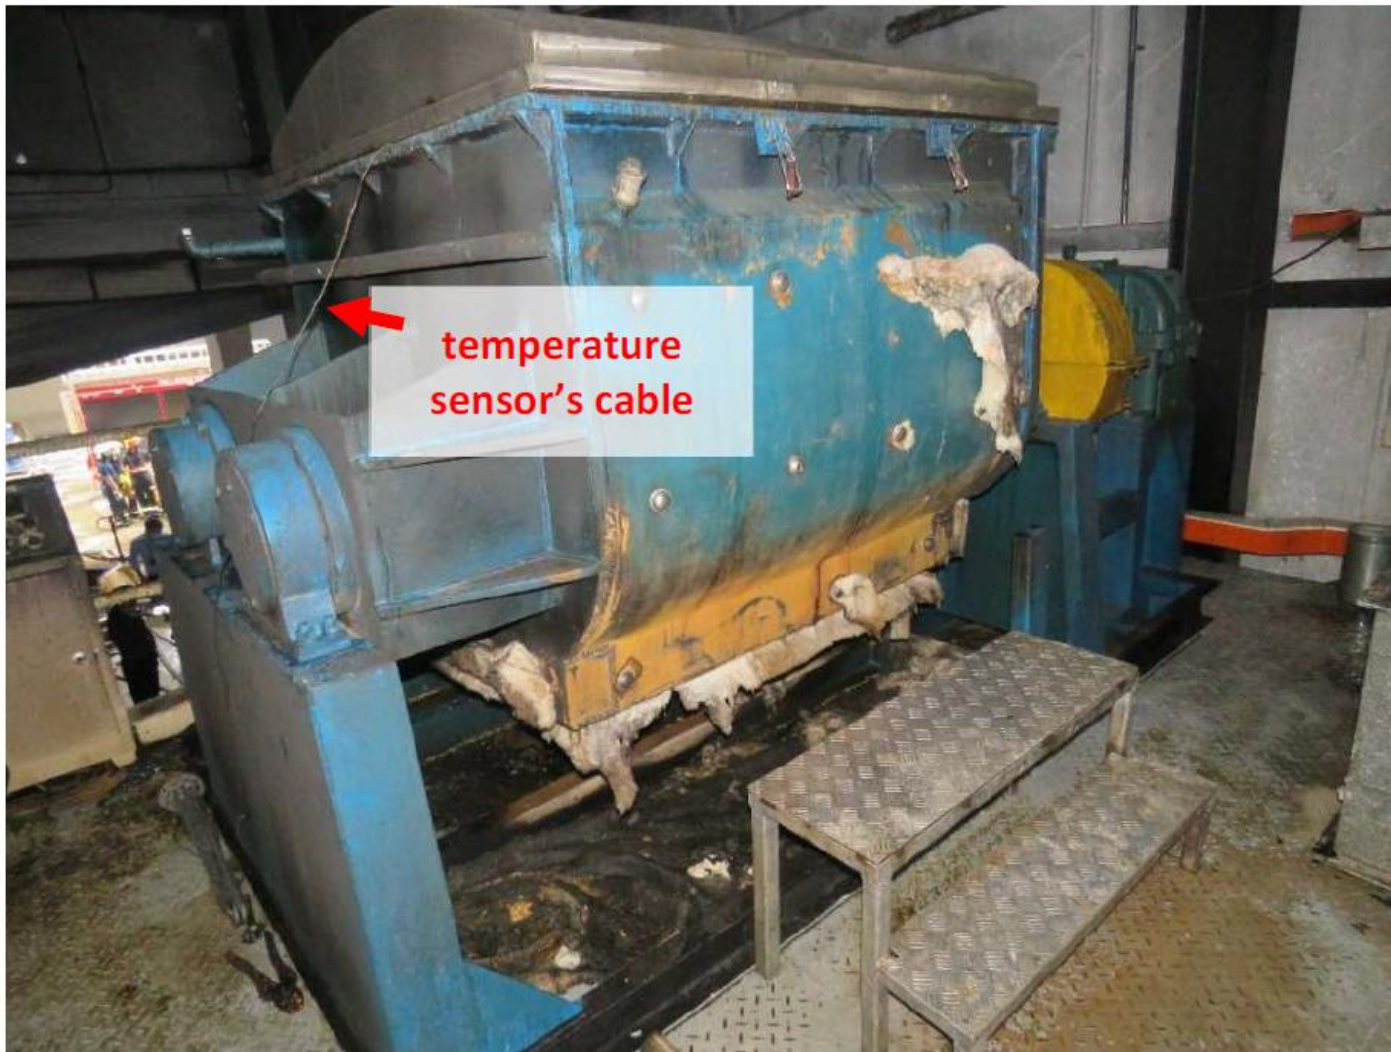
Figure 39: Temperature sensor in mixing chamber

126. A cable from the control panel was found connected to a RTD which was **placed inside the mixing chamber of the mixer machine** (Figure 39)

1 Temperature sensor was not inserted to oil jacket to monitor (and “control”) within safe limits, i.e. below oil boiling point so as to minimise oil vapour generation in jacket. The only one temperature sensor used at mixer chamber is not representative of oil temperature

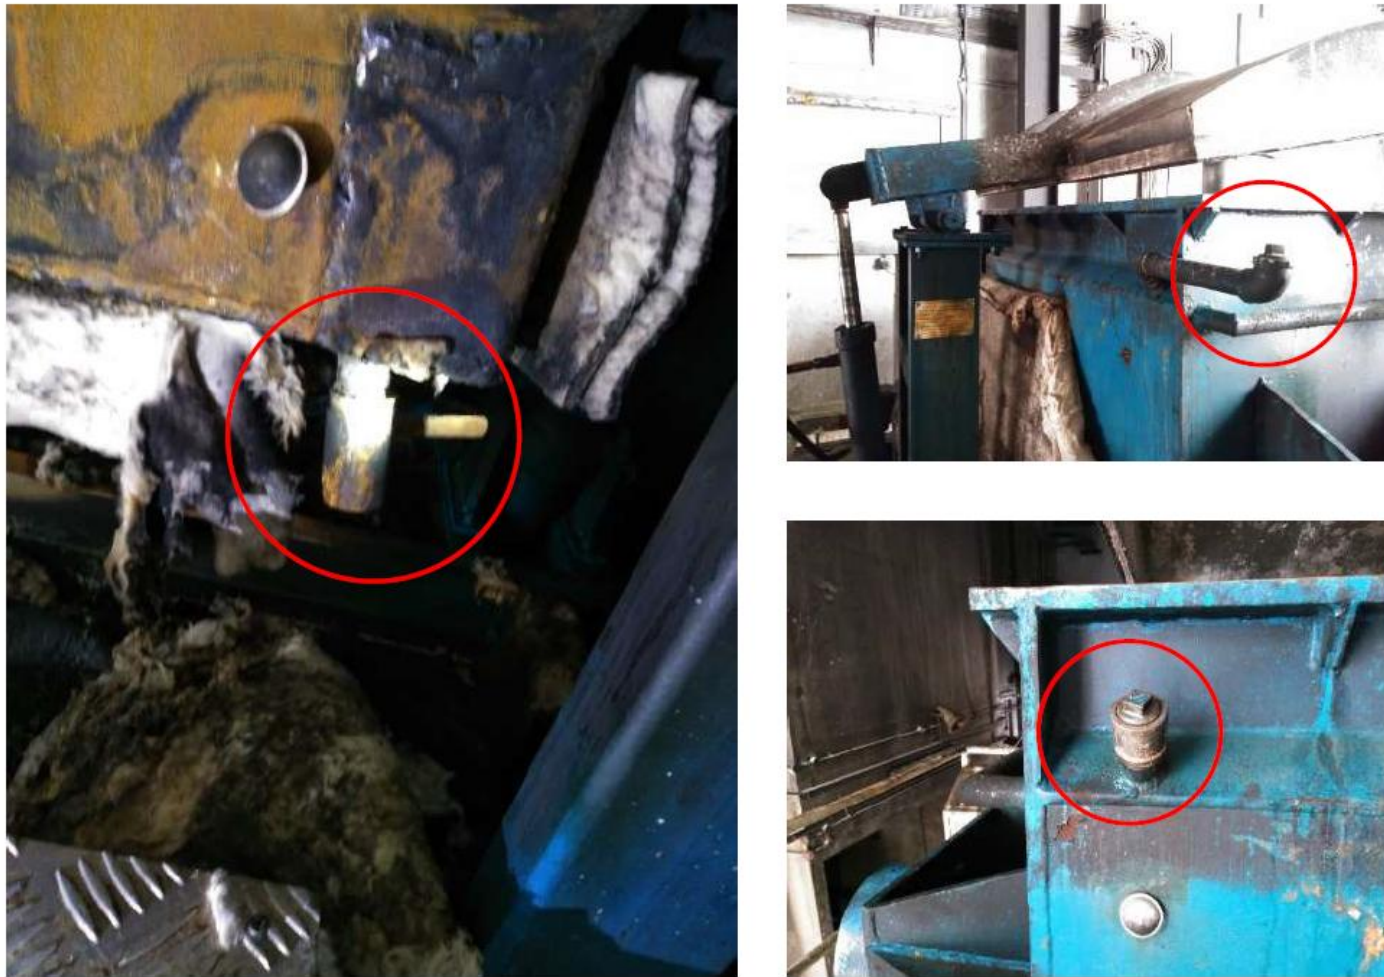
Figure 40: All three openings on the oil jacket circled in red were found closed

126. **All three openings on the oil jacket were found closed post accident.** Both openings at the top of the jacket had end caps that rendered them sealed, while the drain valve was found in a closed position (Figure 40)

2 **Mixer machine oil jacket vent line was sealed / plug to “minimise” thermic oil loss** without a safety relief valve. This is a deviation (wrong modification) from original equipment manufacturer design without risk assessment

2 Mixer machine oil jacket vent line was sealed / plug to “minimise” thermic oil loss without a safety relief valve. This is a deviation (wrong modification) from original equipment manufacturer design without risk assessment

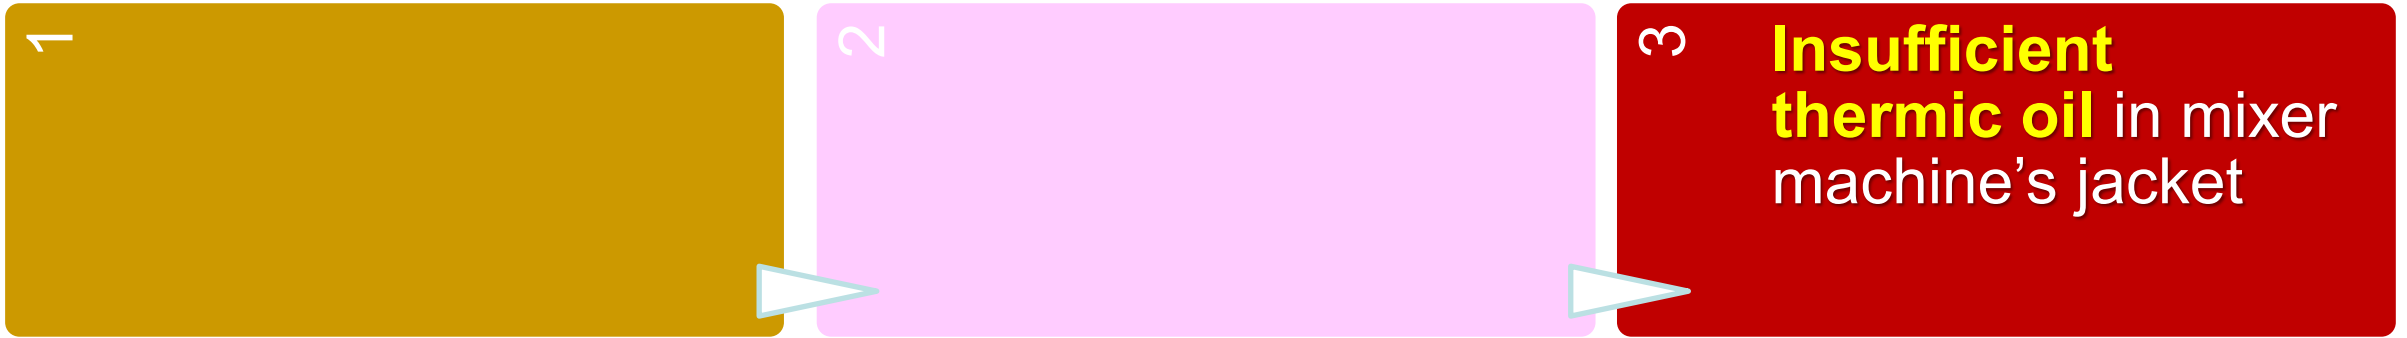
3 There was no proper means to ascertain minimum thermic oil level required before commencement of operations. **Insufficient oil level / without submerging heater elements** not only resulted in inefficient heating of oil, but also overheating of heaters

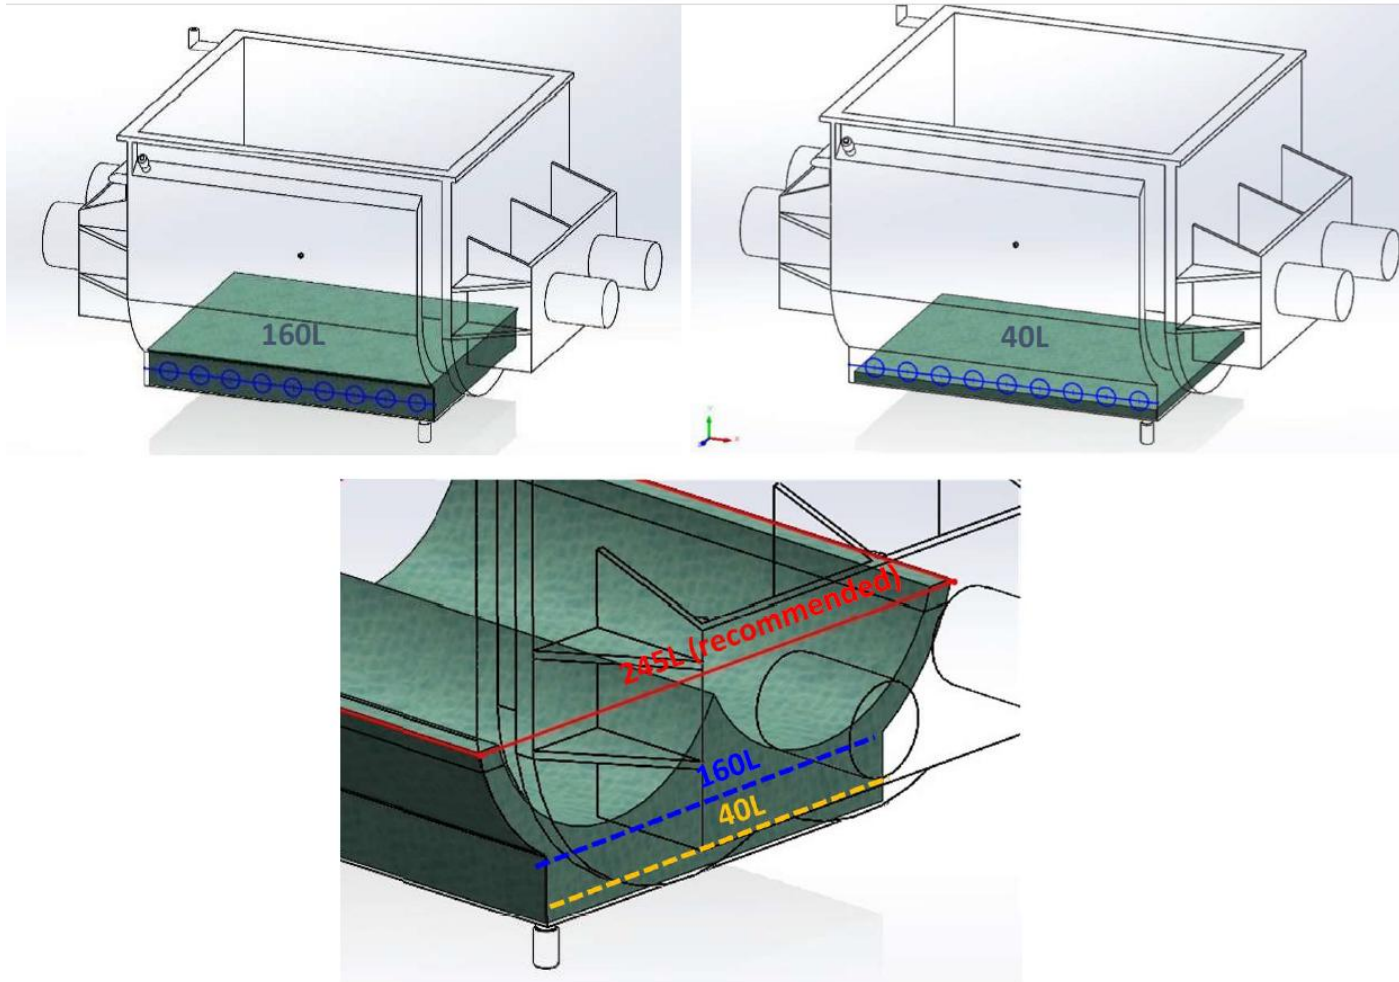
Figure 49: Fill levels corresponding to 40 litres, 160 litres and 245 litres in the oil jacket

141. ...only two buckets, or 40 litres, of oil were added to the oil jacket. As shown in Figure 49, the heaters were not immersed in the thermic oil and there was **a gap between the top of the 40 litres oil level (yellow dotted line) and the lowest point of the mixing chamber...** (Figure 49)

3 There was no proper means to ascertain minimum thermic oil level required before commencement of operations. Insufficient oil level / without submerging heater elements not only resulted in inefficient heating of oil, but also overheating of heaters
