Bridging Safety Gaps in Combustible Dust Management – Lesson and prevention strategies from past incidents

November 20, 2024

Dilip Arulappan
Explosion Safety Consultant

Case study – Didion Milling

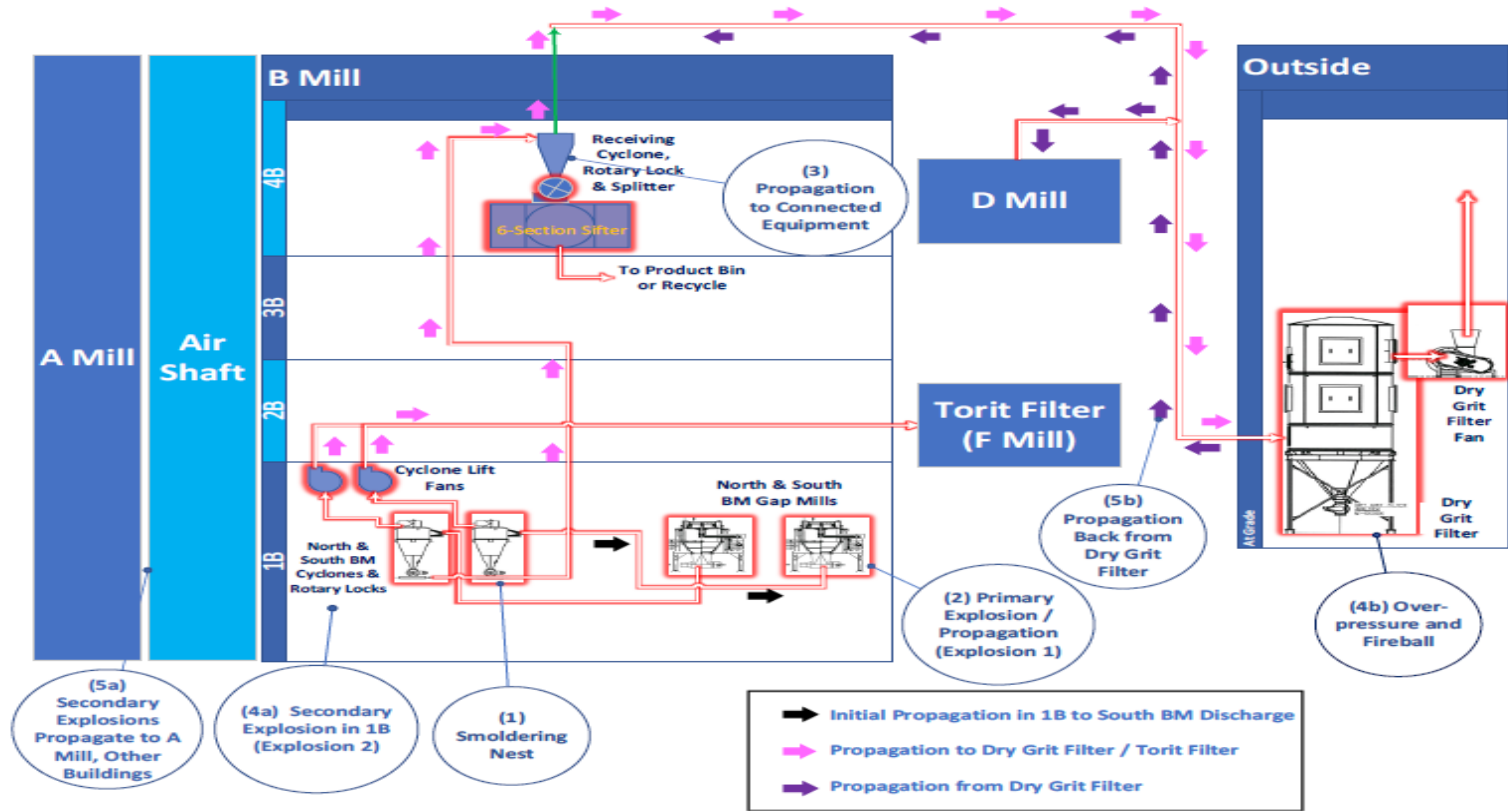
Didion Milling – Incident analysis

The likely incident progression involved a series of events and phenomena, which can be described in these steps:

1. A **smoldering nest** developed in the Bran process, likely downstream of the South BM.
2. A **primary explosion** (Explosion 1) occurred inside Bran process equipment, likely located in 1B.
3. The primary explosion **propagated** inside the interconnected process equipment.
 - 4a. The **first secondary explosion** (Explosion 2) occurred on 1B.
 - 4b. Within a few seconds of Explosion 2, the **Dry Grit Filter overpressured** and released a fireball.
 - 5a. A **series of secondary explosions** begins throughout the mill buildings, resulting in significant building damage and collapse.
 - 5b. At approximately the same time, a **deflagration propagated from the Dry Grit Filter back toward** other process equipment through piping and ductwork.

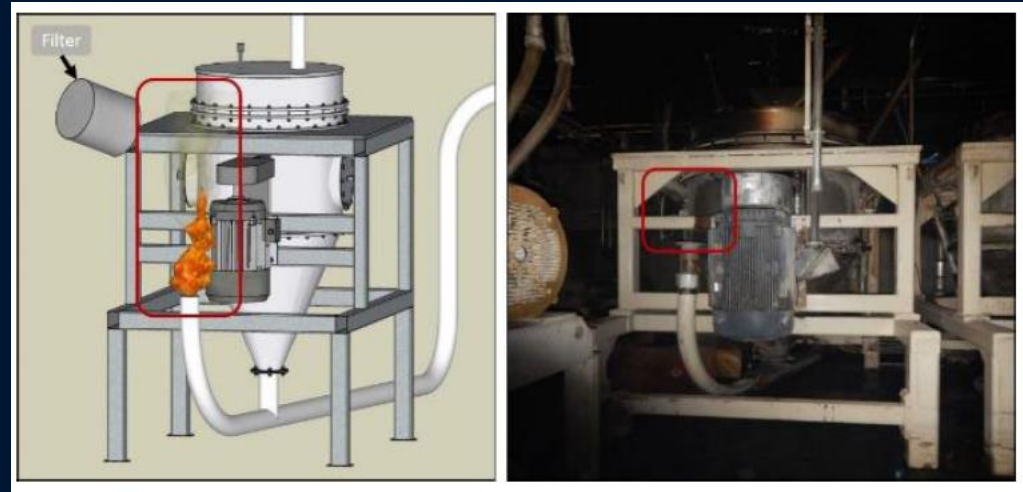
Didion Milling – 2 - Primary explosion 1

“The CSB concludes that either an oscillating flame front or a series of small explosions spread burning material throughout the Bran process piping on 1B and accelerated a localized smouldering nest into a deflagration.”

- Employees heard a huge boom and saw the air intake filter blow off the south BM transfer line to the south cyclone. Corn dust material and flames were noted coming out of the air intake for the transfer line.
- Employee B noted that the flame was visible for several seconds, was “sucked back in,” and then reappeared – **Indicative of an oscillating flame.**
- Rae (1973) and Eckhoff et al. (1987) have performed research on oscillating flame front behaviour
- The same behaviour was observed in the south BM discharge.

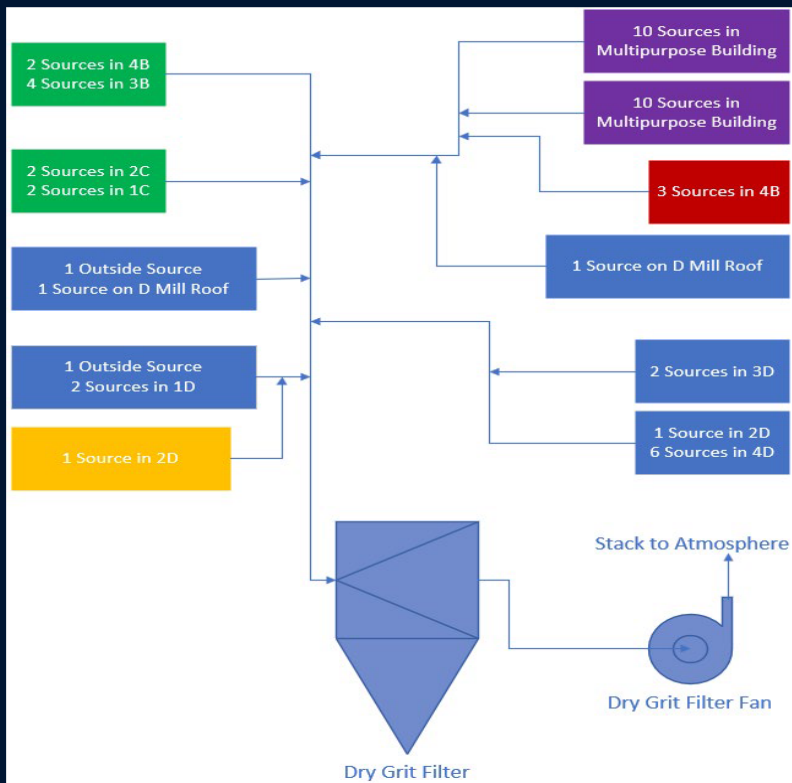
2) Equipment Interconnectivity

- The CSB concludes that Didion did not recognize the propagation hazard that interconnecting numerous pieces of equipment presented.
- NFPA 61 (2008 through 2020 editions) also references NFPA 91 Standard for Exhaust Systems for Air Conveying of Vapors, Mists, and Particulate Solids regarding duct systems for air-material separators. NFPA 91 (2010-2020 editions) requires: *Ducts from a single piece of equipment or from multiple pieces of equipment interconnected on the same process stream shall be permitted to be manifolded. [...] Ducts from nonassociated pieces of equipment shall be permitted to be manifolded provided that each duct is equipped with an isolation device prior to manifolding in accordance with NFPA 69, Standard on Explosion Prevention Systems [49, p. 11] [50, p. 13] [51, p. 7.1.9.2].*

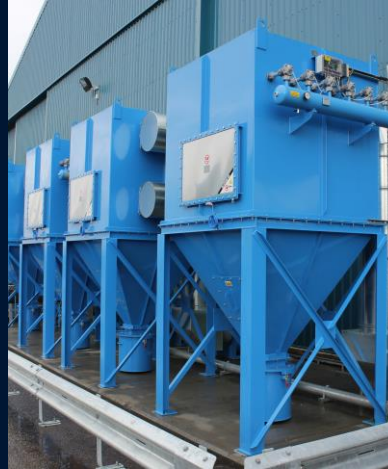
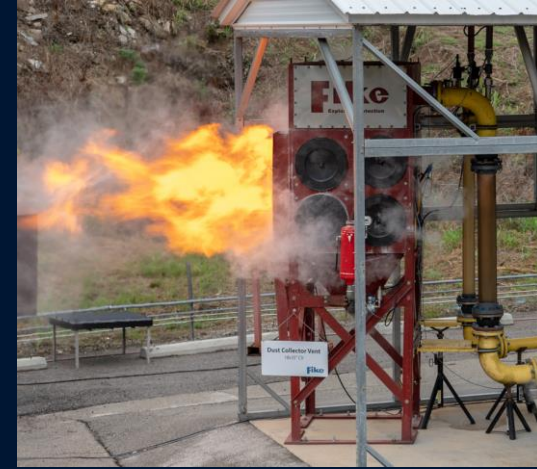
Deflagration Venting Deficiencies

NFPA 68, Chapter 6.6.1 – *The material discharged from an enclosure during the venting of a deflagration shall be directed outside to a safe location.*

- No explosion protection.
- Deflagration vents located inside buildings, directed into the building.
- Deflagration vents located inside buildings ducted to the outside incorrectly.
- Deflagration vents without adequate space to properly relieve.
- Deflagration vents directed to potentially occupied locations.
- Undersized deflagration vents.

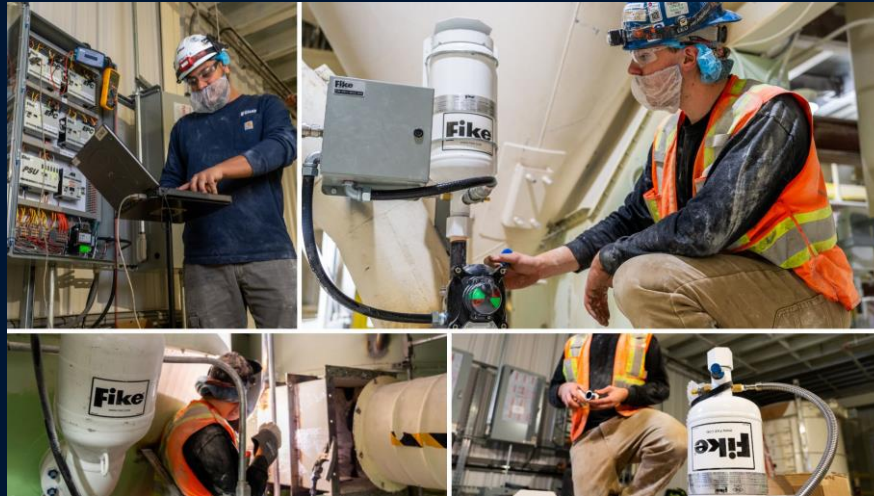
Explosion Suppression Deficiencies

- Common findings:
 - Not conducting the required quarterly inspections on the system.
 - Not providing training to maintenance and other affected employees that would have to work on the protected piece of equipment.

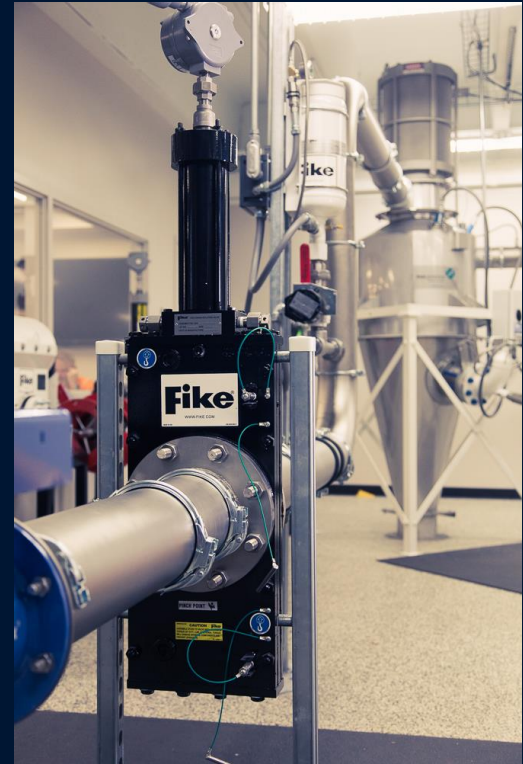
Isolation Valve & Abort Gate Deficiencies

- Common findings:
 - Isolation valves not certified by a recognized testing organization.
 - Abort gates pointed downwards to potentially occupied locations.
